# TIMPVIEW HIGH SCHOOL EVALUATION

3570 North 650 East Provo, Utah 84604

**BUILDING EVALUATION**

The following report is the architectural evaluation of Timpview High School for Provo School District. The evaluation took place in November 2012.

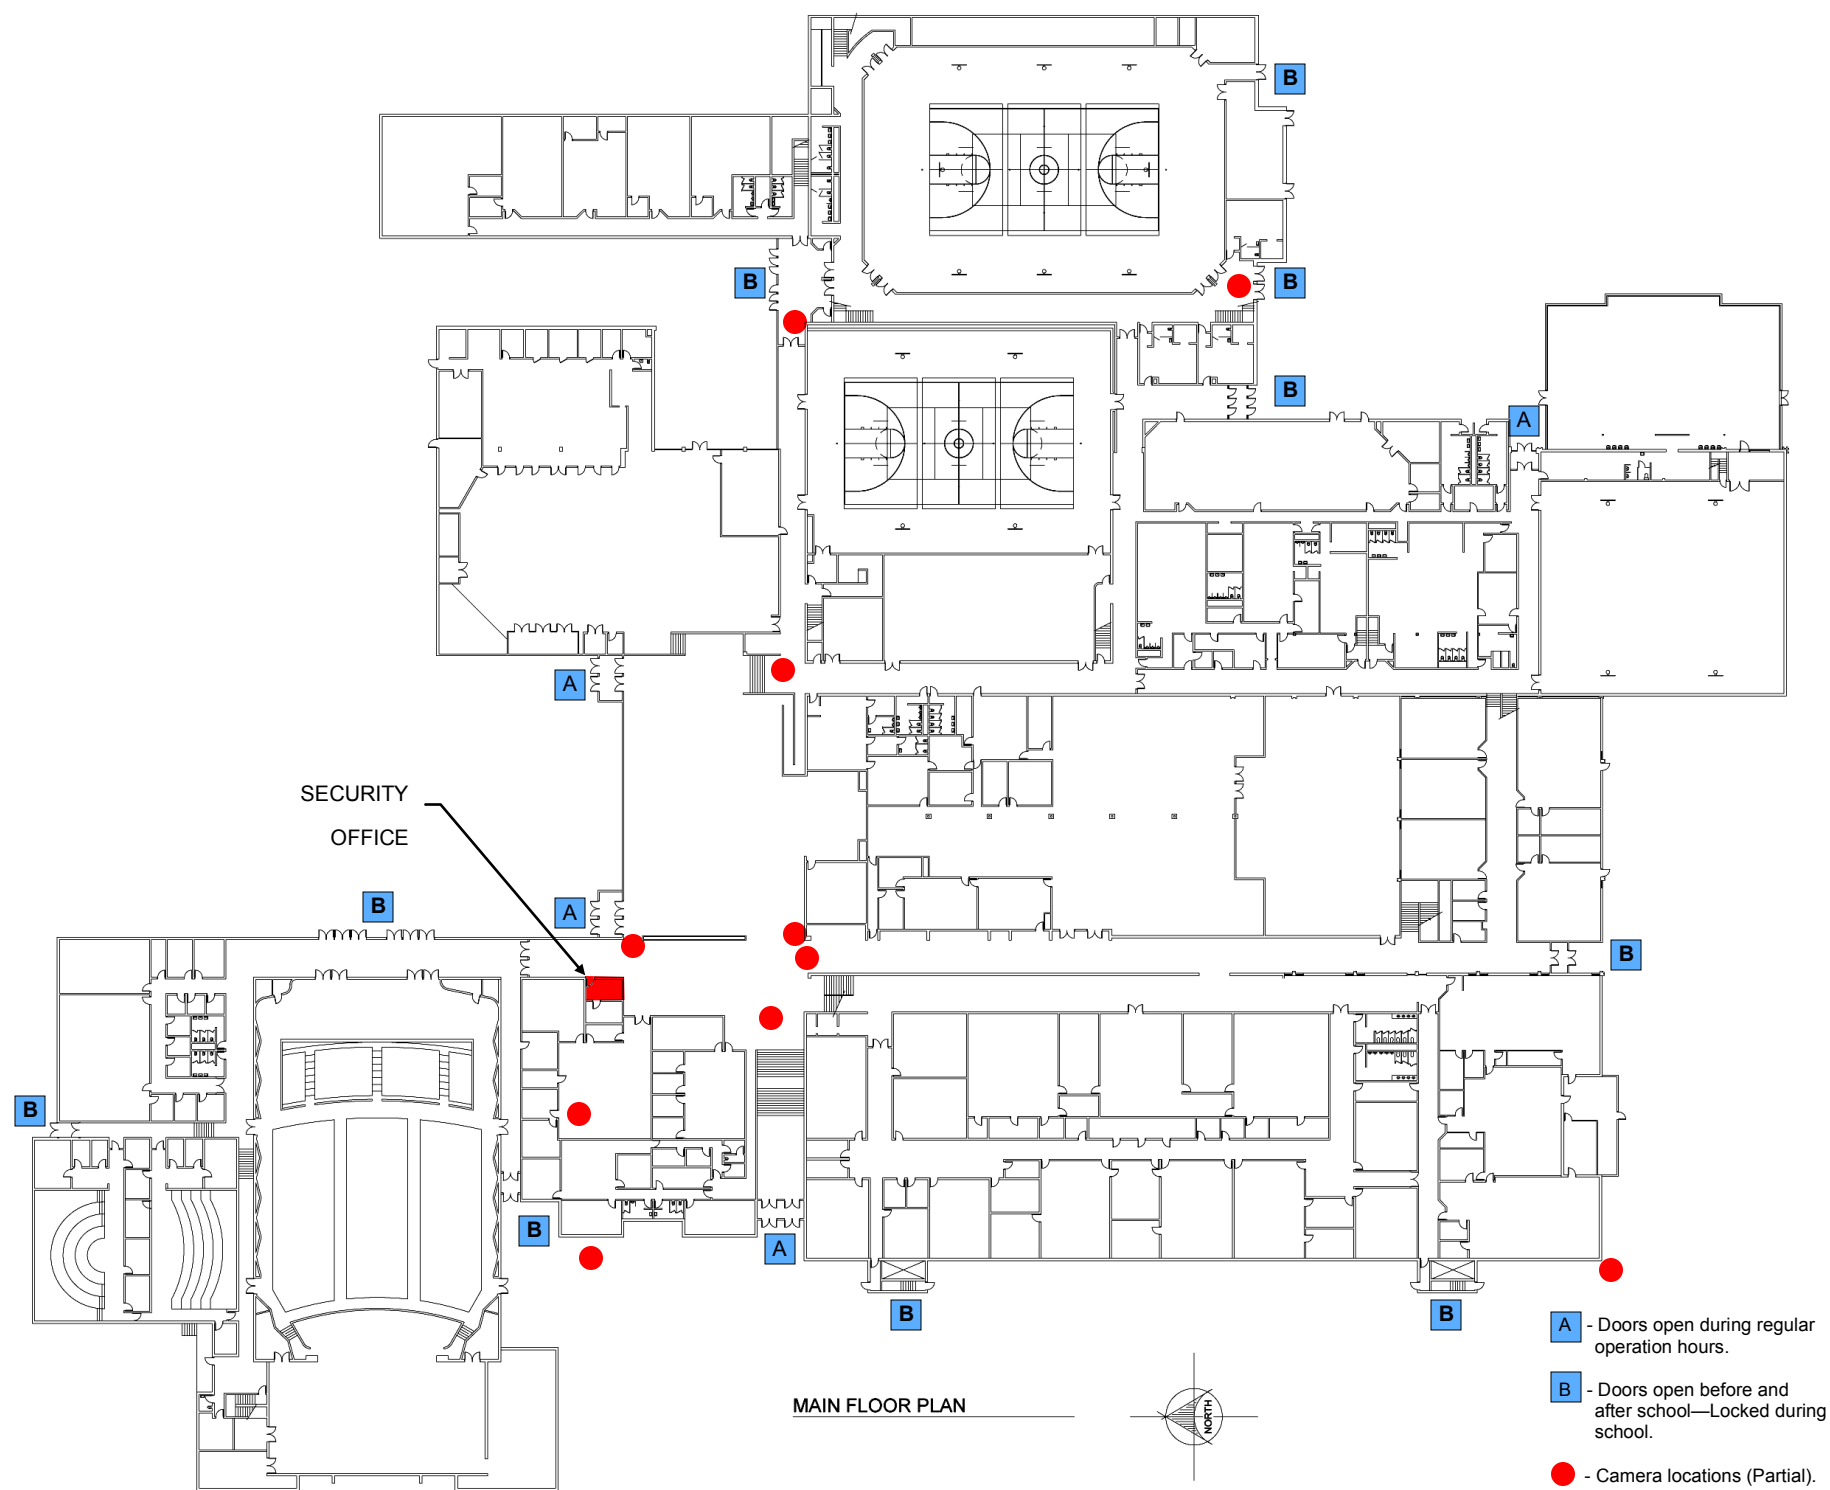
- This school is an open campus that at least 20% of the entrance doors are open during school hours. The main entrance is always open as well as the north entries to the commons. The east door adjacent to the new weight room is unlocked at certain times for classes during the day.
- Please see the adjacent plan for camera locations and lockdown access.

- A** - Doors open during regular operation hours.
- B** - Doors open before and after school—Locked during school.
- - Camera locations (Partial).

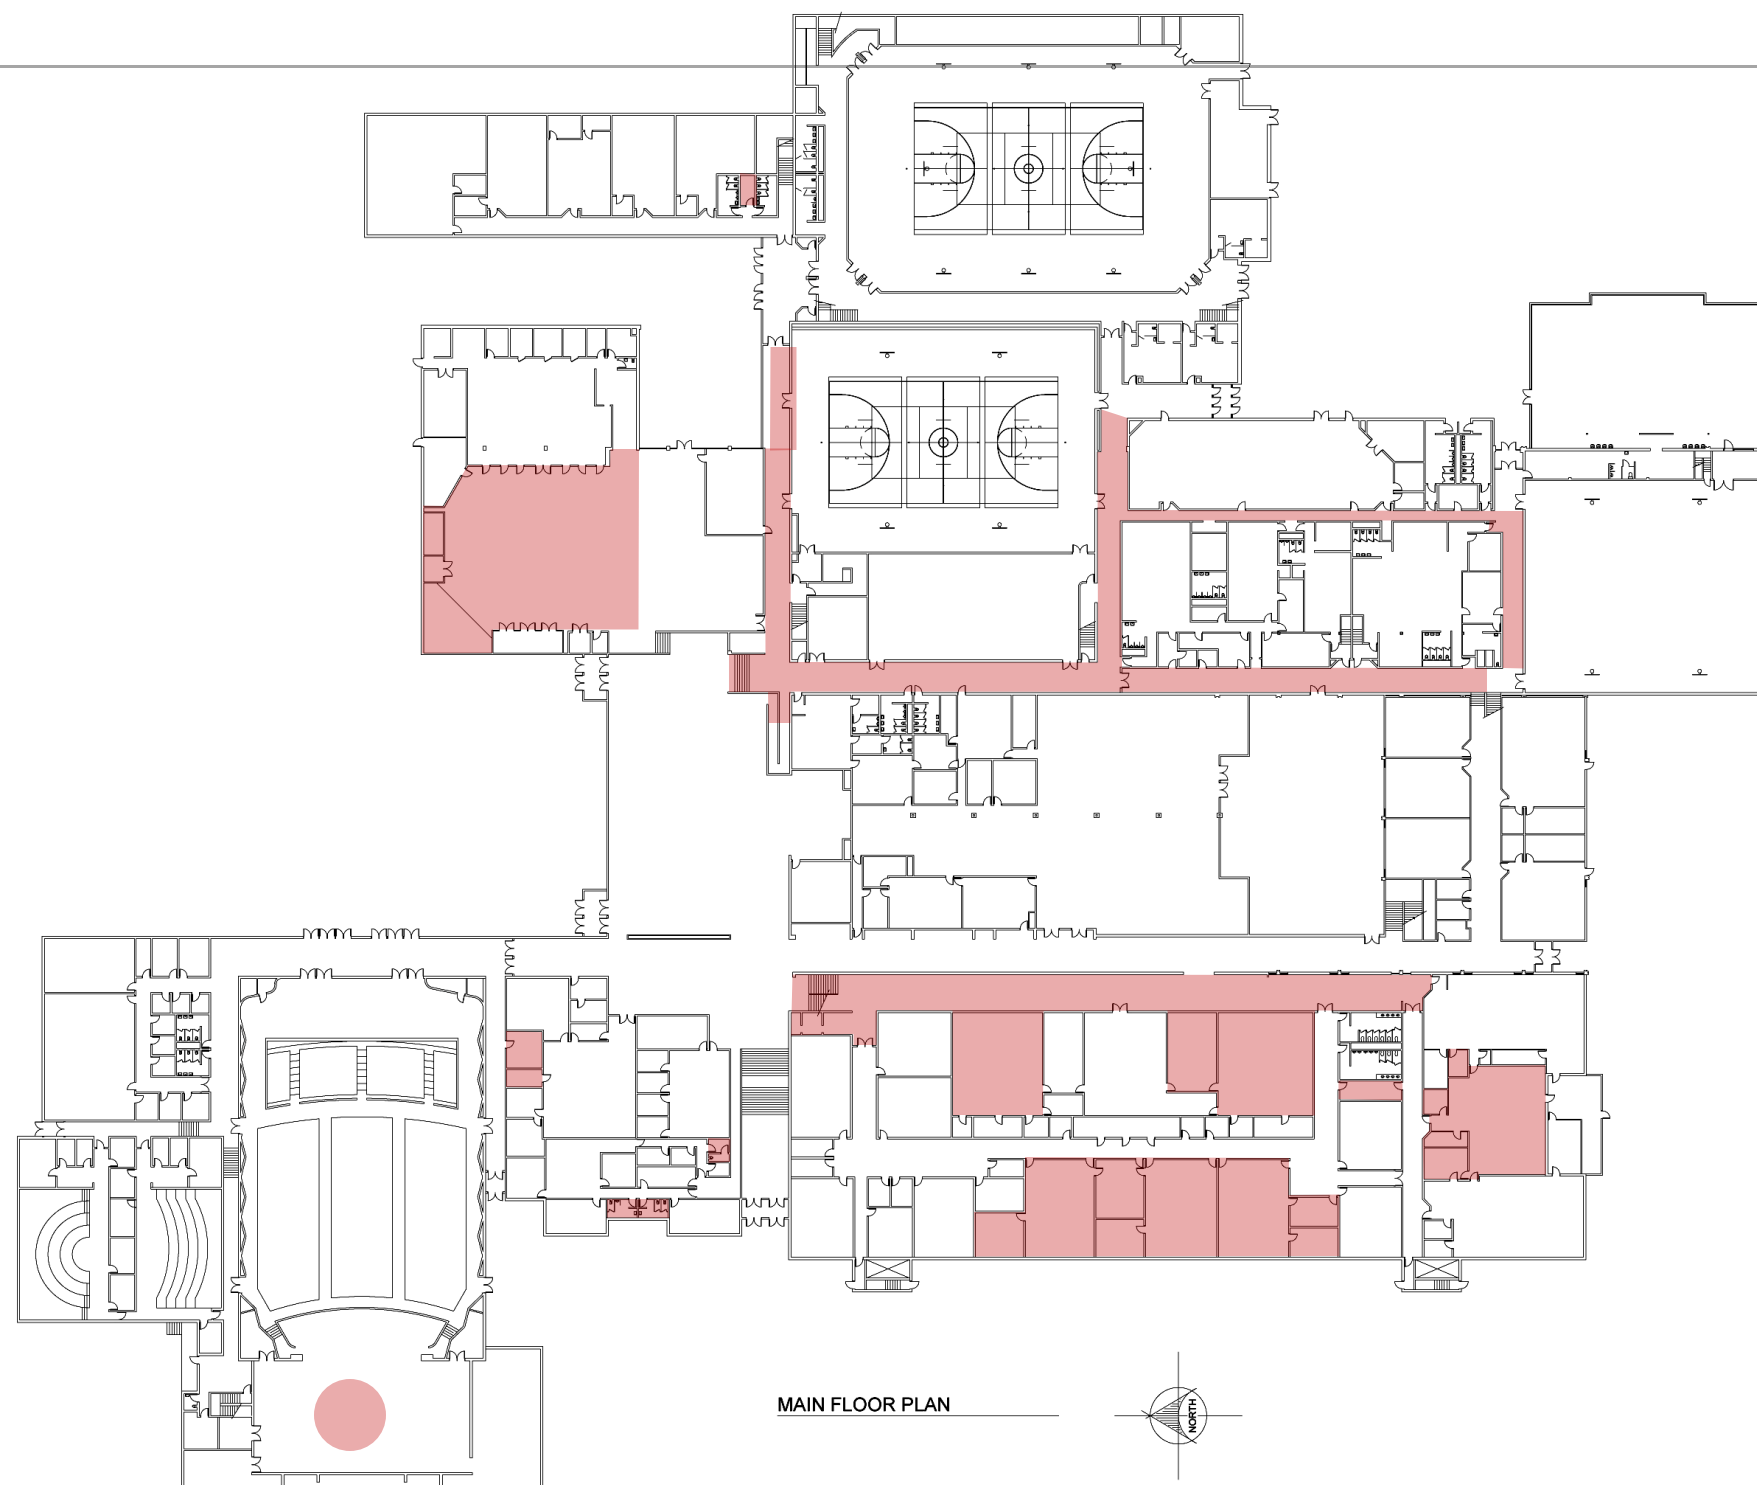
MAIN FLOOR PLAN

- 1- ACM 12" Floor tile, Lt. Grey w/ Tan and cream streaks, and dark gray mist.
- 2- ACM 12" Floor tile, Tan w/ white and brown flecks, sparse pattern.
- 3- ACM Linoleum backing, under orange, olive, and cream mosaic linoleum.
- 4- ACM Sinks.
- 5- Transite Tables/counter tops.
- 6- Transite vent hood.
- 7- ACM-Wired light fixtures (stored or otherwise)

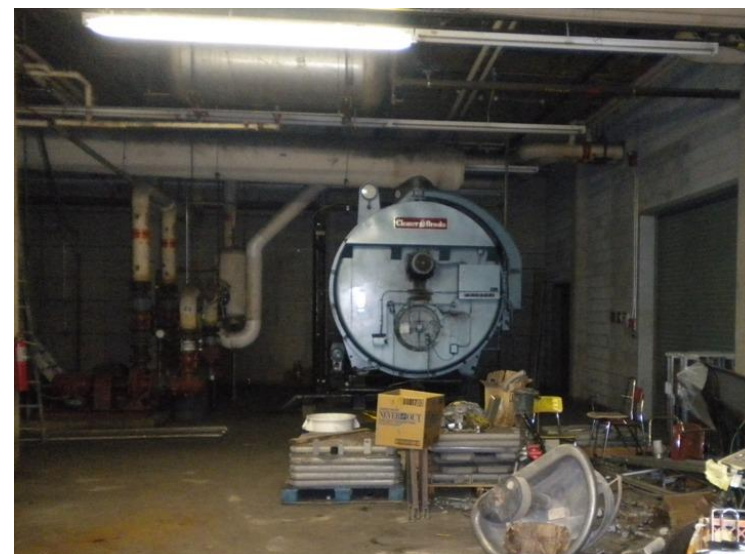
- The (2) original Cleaver Brooks hot water boilers are located in the boiler room on the north side of the school.
- West boiler was repaired in late 2012.
- Boiler controls were updated in 2014.
- Heating pumps were replaced in 2014.
- Building air handlers are provided with hot water coils with coil pumps. Air handling units are original to the school.
- General building:
  - AH-4, 5, 6 & 7 are located in a mezzanine fan room above the wrestling area. Dampers & Fan motors were replaced in 2014. VFD's were provided for new supply & return fan motors. Associated controls were updated in 2014.
  - AH-11, 12, & 13 are multi-zone units and are located in the south end of the mezzanine fan room above the wrestling room. Units are single speed. No VFD's are provided for fan motors.

Figure 1. Existing Heating Boiler

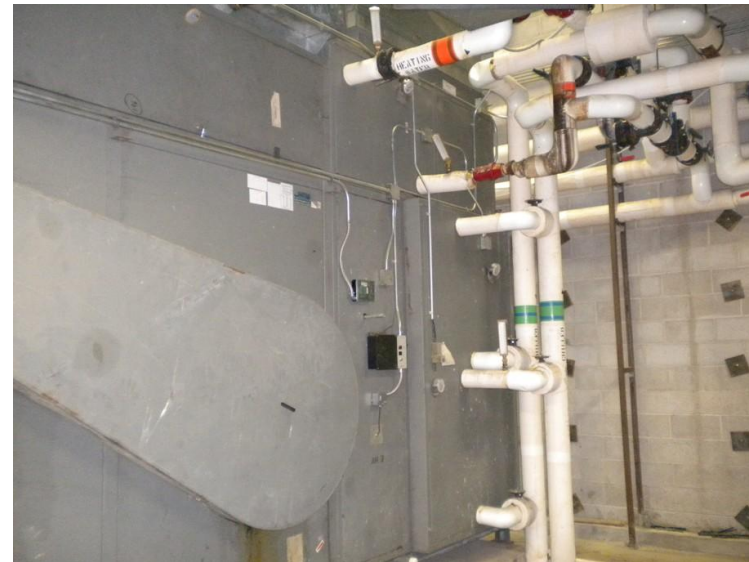
Figure 12. Existing Control Station Air Handler with CW Coil

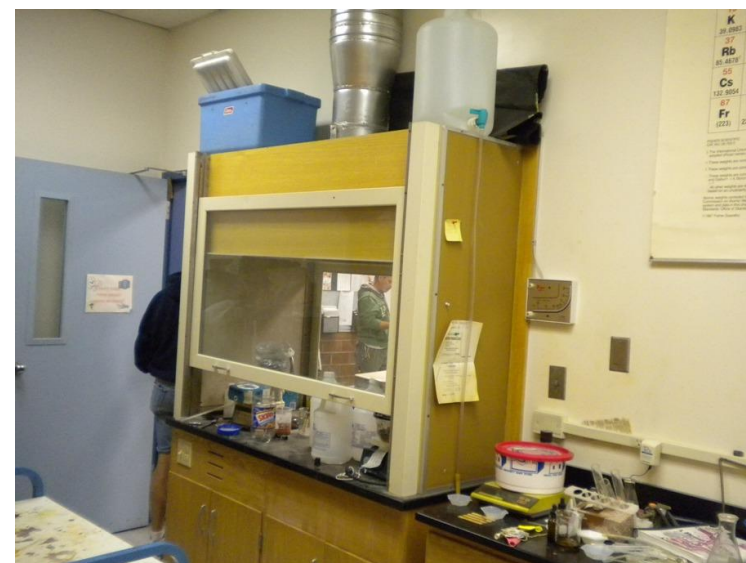
**Figure 21. Science Room Fume Hood**

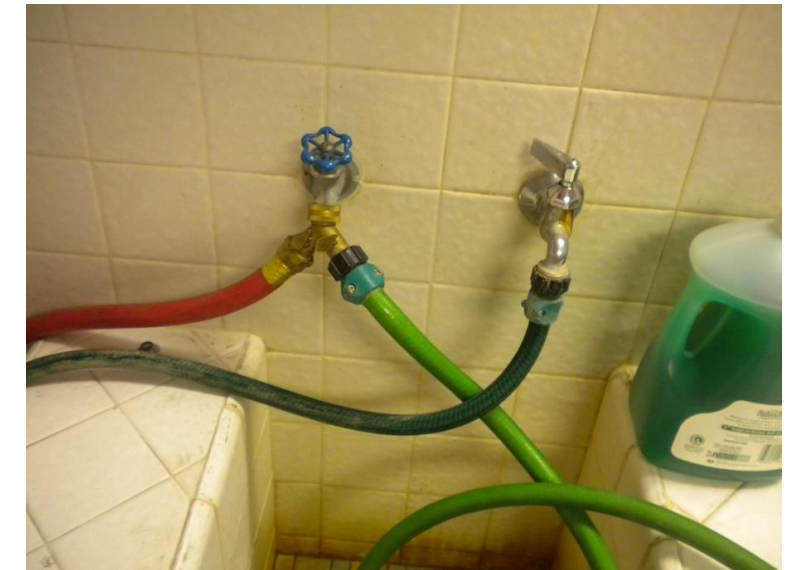
Figure 32. Code Violation at Athletic Training Room  
"No Vacuum Breakers"

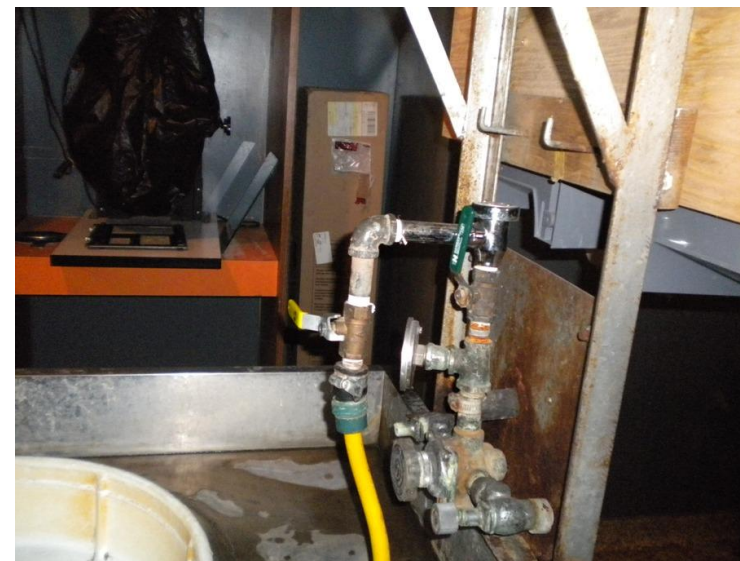
Figure 33. Domestic Water Connection to Hose  
With No Vacuum Breaker

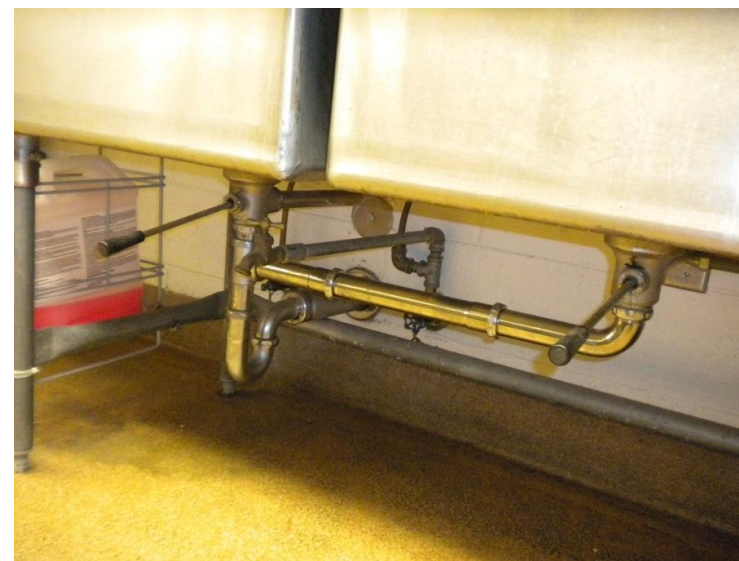
Figure 41. Hose Bibbs at Kitchen with No Vacuum Breaker Code Violation
