# OBSERVATION REPORT

**RE:** Timpview High School  
3570 Timpview Drive  
Provo, Utah 84604  
Ensign Engineering Project No.: 8907A

## Observation Notes (Related to Structural):

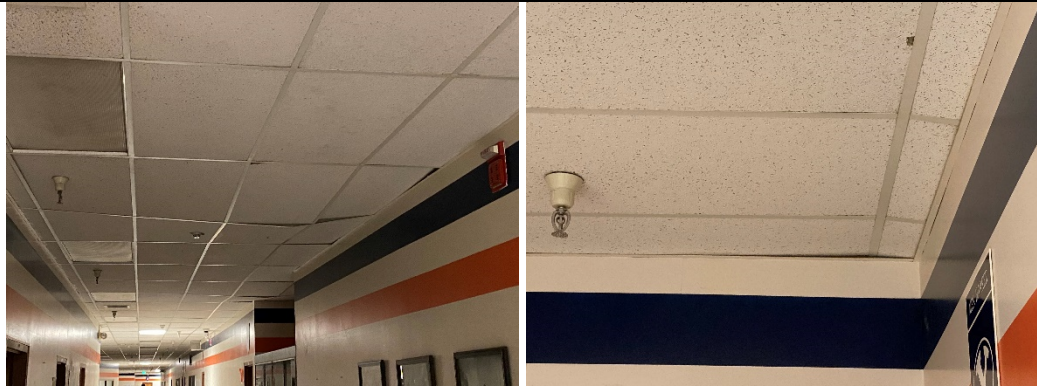
1.	<u>Observation Item:</u> Buckling of ceiling tile in hallway on the second level of the west academic wing.

The fact that the building continues to show signs of settlement and distress reinforces the need of remediation and stabilization at this site if the PCSD decides to not build a new facility. It is our opinion that the building will continue to settle, and will further present additional signs of distress over time.

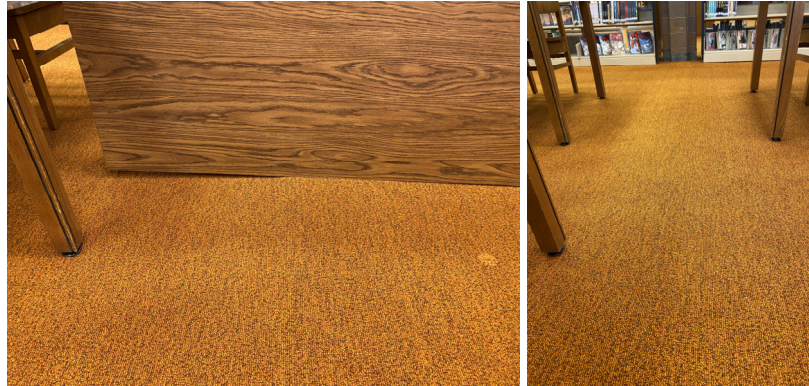
2. Observation Item: Settlement of slab on grade in media center. We need to compare this to the previous survey to determine how much the surface in this area has changed over the last year.

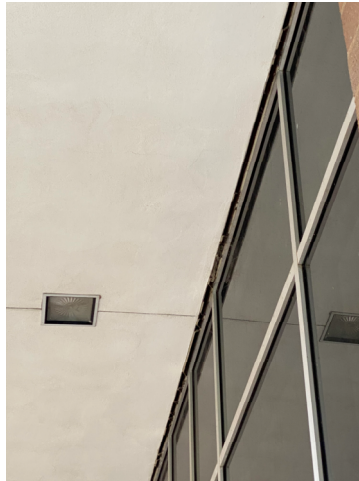
3. Observation Item: Additional movement of window in media center.

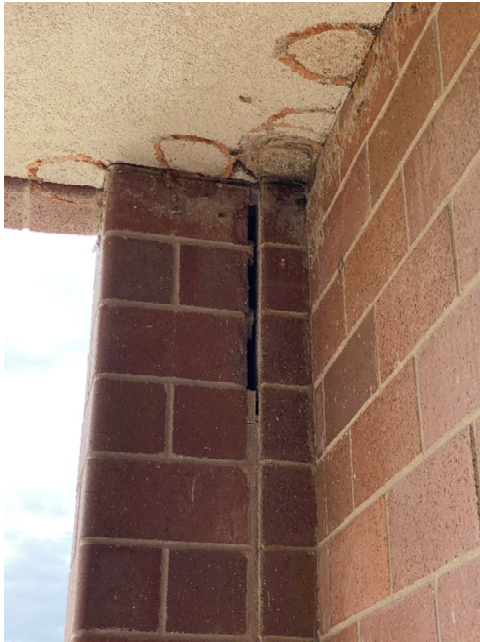
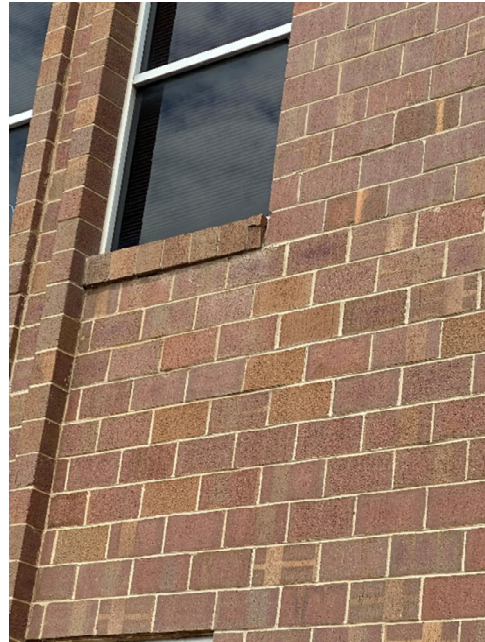
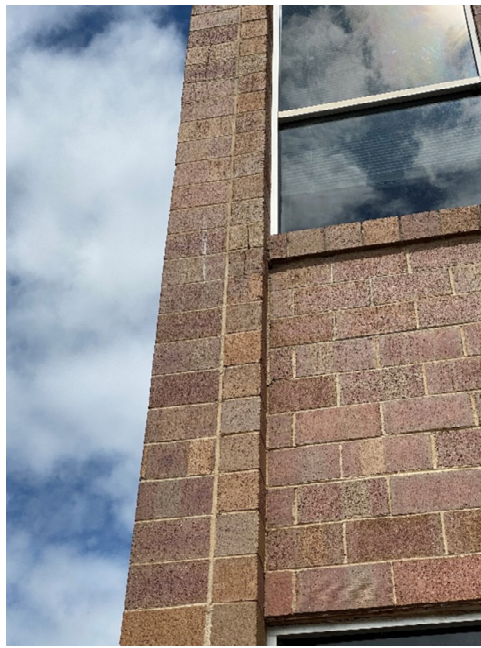
4. Observation Item: Noted cracks in masonry wall on south side of west academic wing.
