**CENTENNIAL MIDDLE SCHOOL - MASONRY
CLEAN & RE-SEAL**

305 E 2320 N
PROVO, UT 84604

BID DOCUMENTS

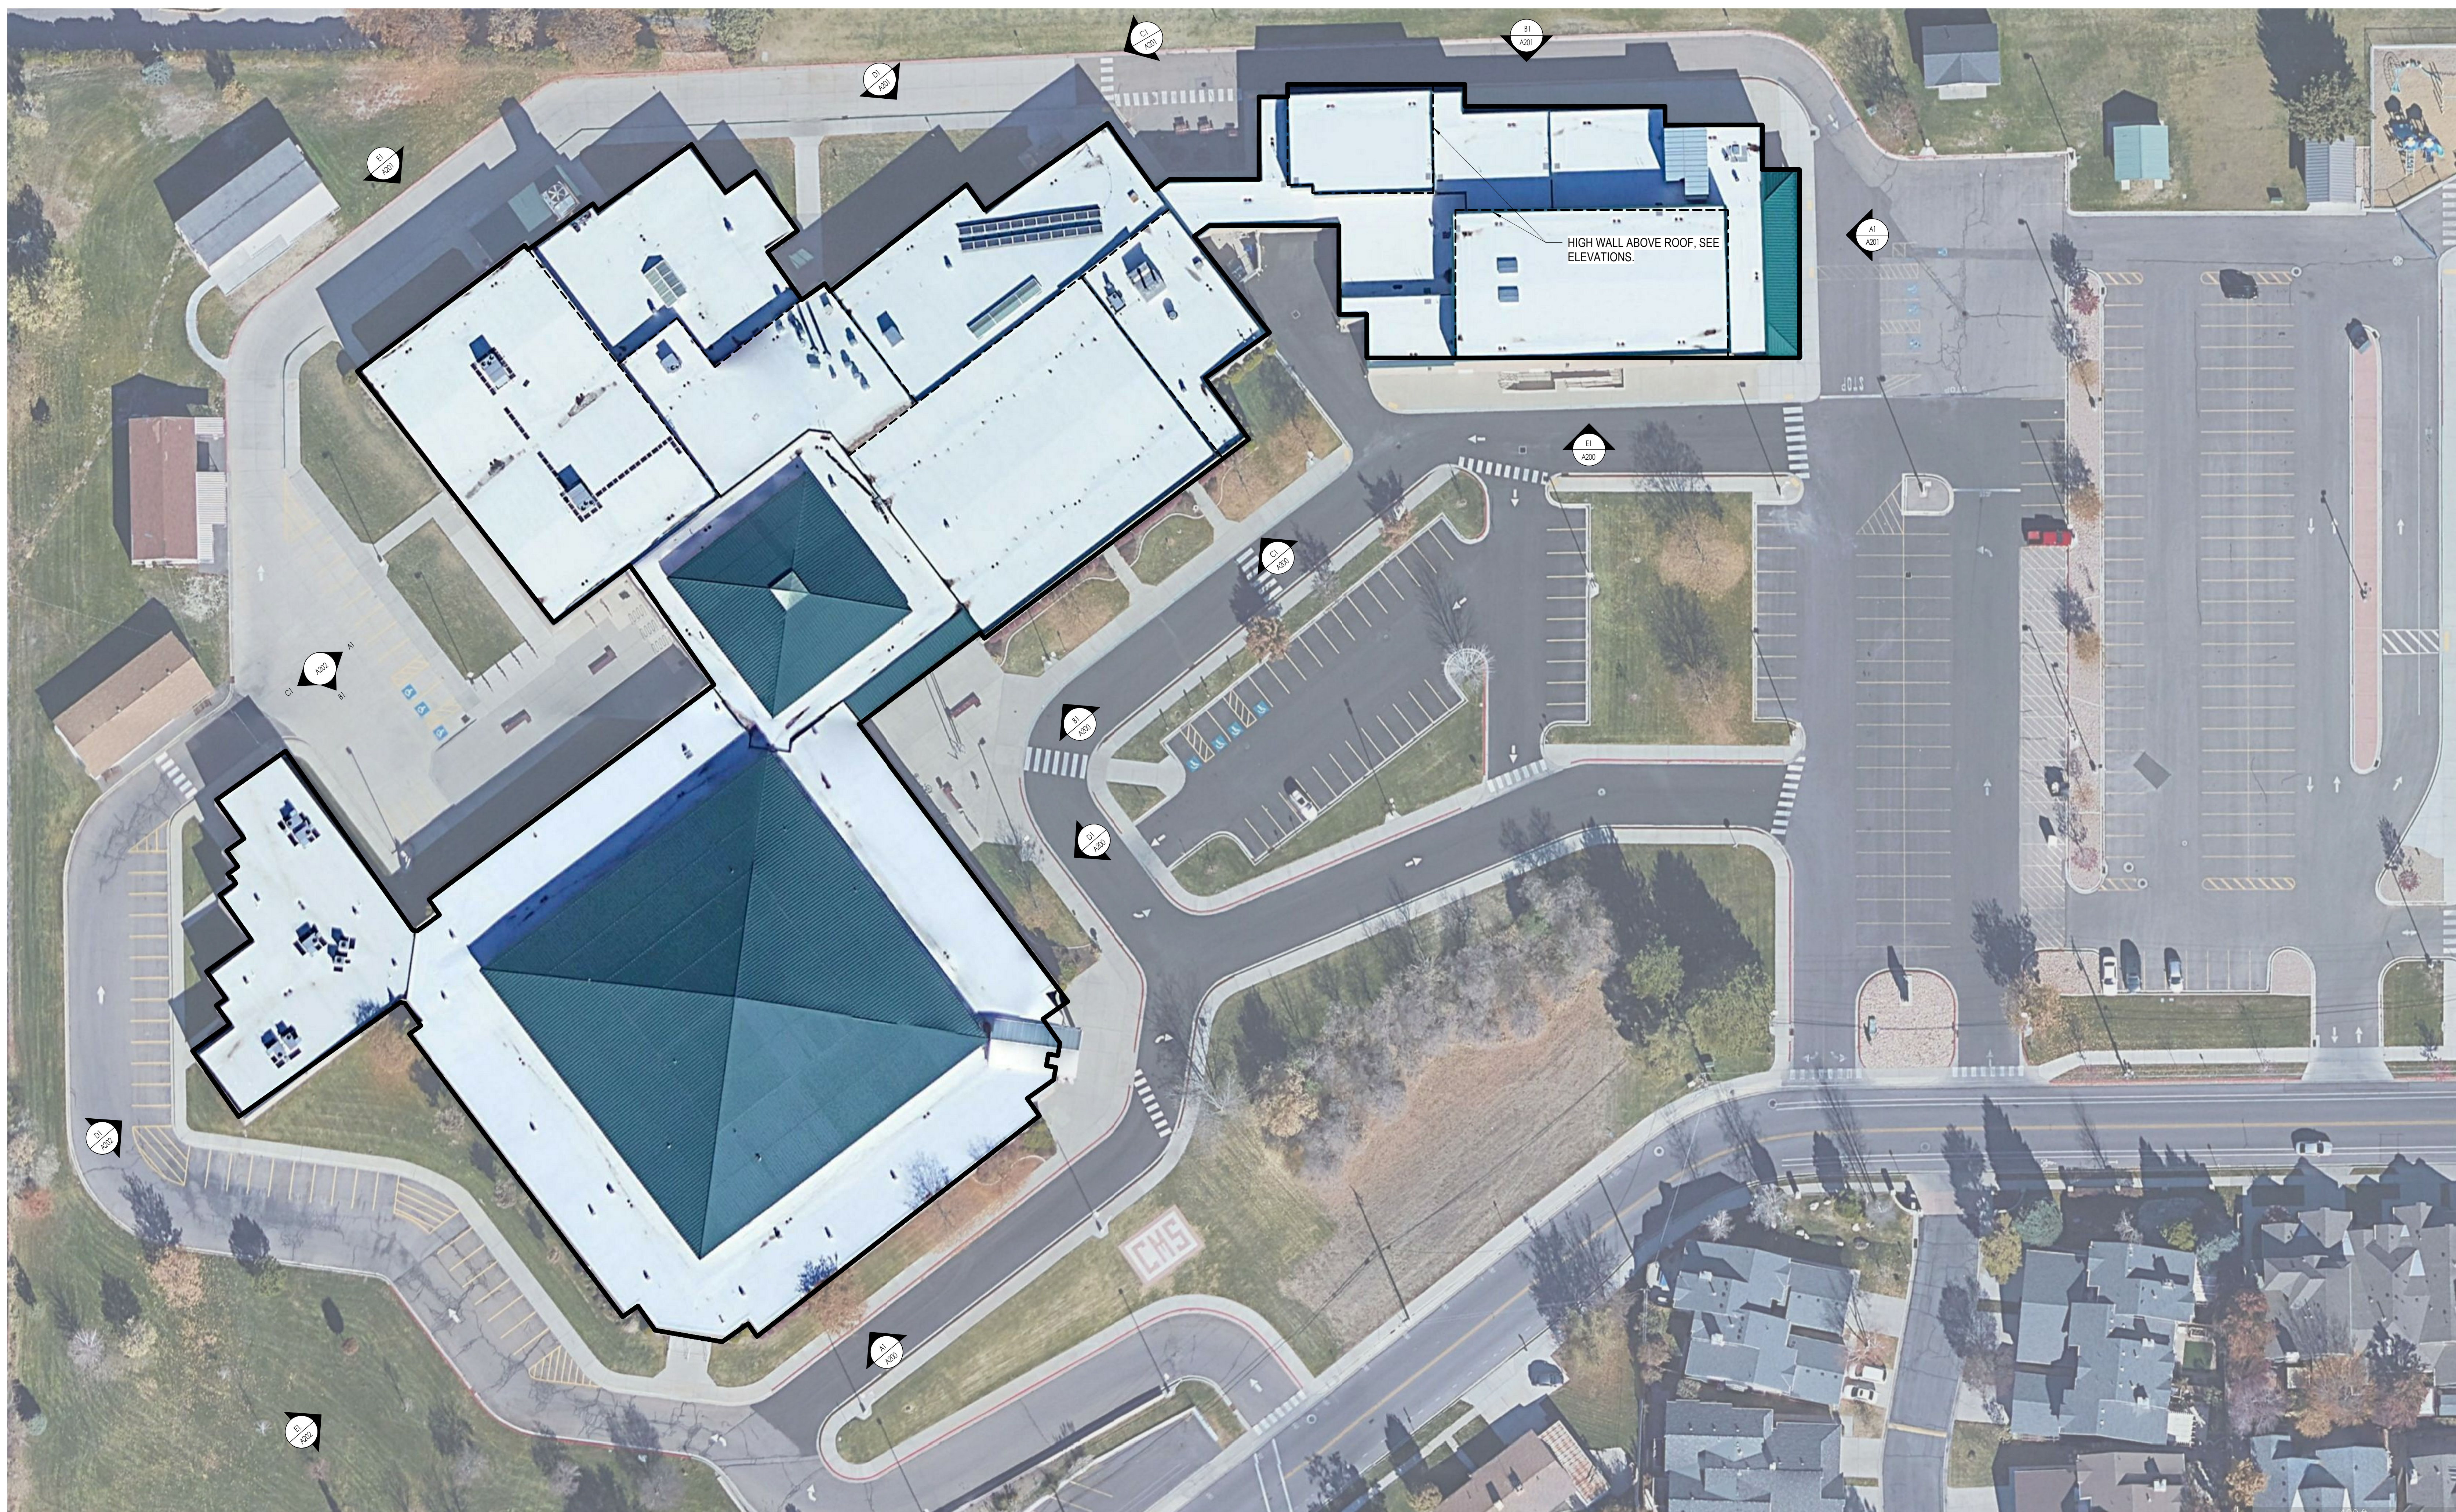
E1 SITE PLAN
A001 | SCALE: 1" = 30'-0"

- MASONRY HAS CRACKED AND MOVED OUT OF ALIGNMENT. REPAIR. SEE REFERENCE IMAGE 33/A204.
- EXISTING MASONRY CLEAN & RE-SEAL.
- CONTROL JOINT, REMOVE EXISTING CAULK & BACKER ROD. CLEAN JOINT & ADD NEW BACKER ROD & CAULK.
- MECHANICAL ROOF TOP UNIT.
- EXISTING EIFS MEDALLION, N.I.C.
- EXISTING EIFS, N.I.C.
- EXISTING EIFS CANOPY AND COLUMNS, N.I.C.

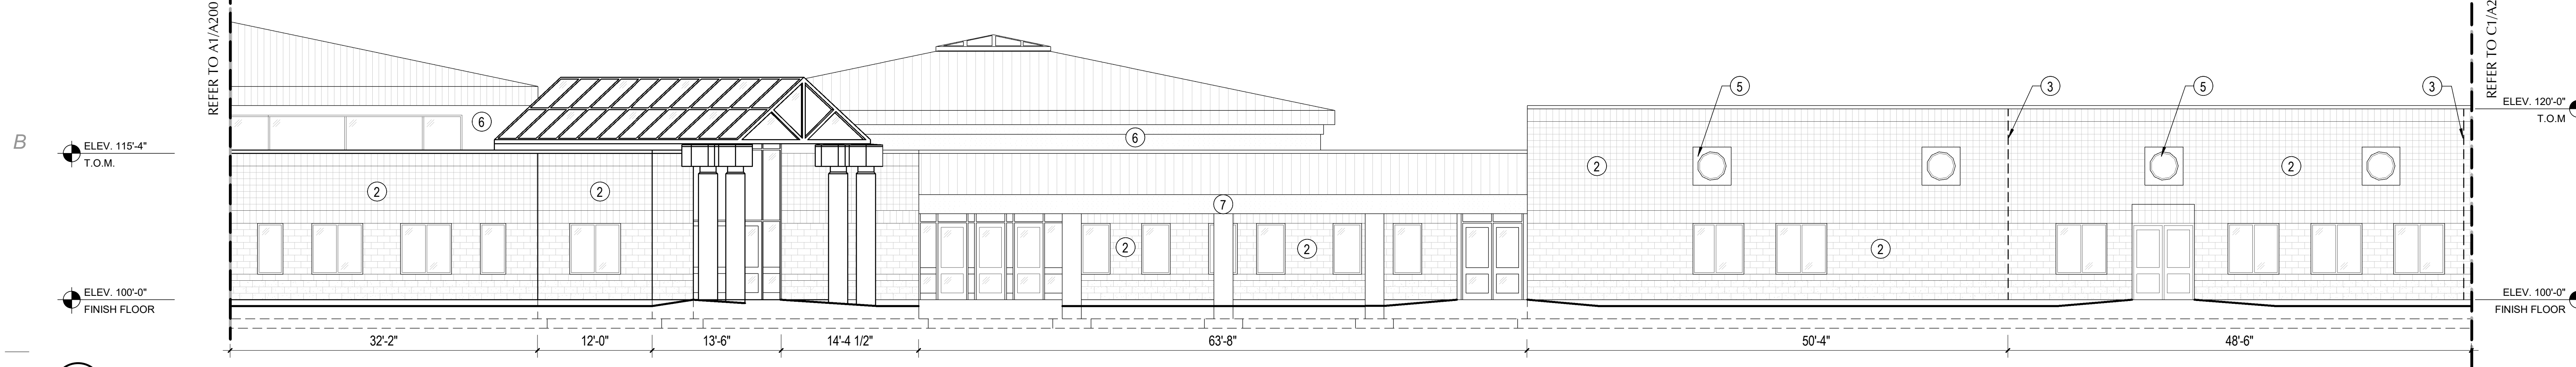
B1 SOUTH EAST ELEVATION PART 2
A200 | SCALE: 1/8" = 1'-0"

- 1. MASONRY HAS CRACKED AND MOVED OUT OF ALIGNMENT, REPAIR. SEE REFERENCE IMAGE 33/A204.
- 2. EXISTING MASONRY CLEAN & RE-SEAL.
- 3. CONTROL JOINT, REMOVE EXISTING CAULK & BACKER ROD. CLEAN JOINT & ADD NEW BACKER ROD & CAULK.
- 4. MECHANICAL ROOF TOP UNIT.
- 5. EXISTING EIFS MEDALLION, N.I.C.
- 6. EXISTING EIFS, N.I.C.
- 7. EXISTING EIFS CANOPY AND COLUMNS, N.I.C.

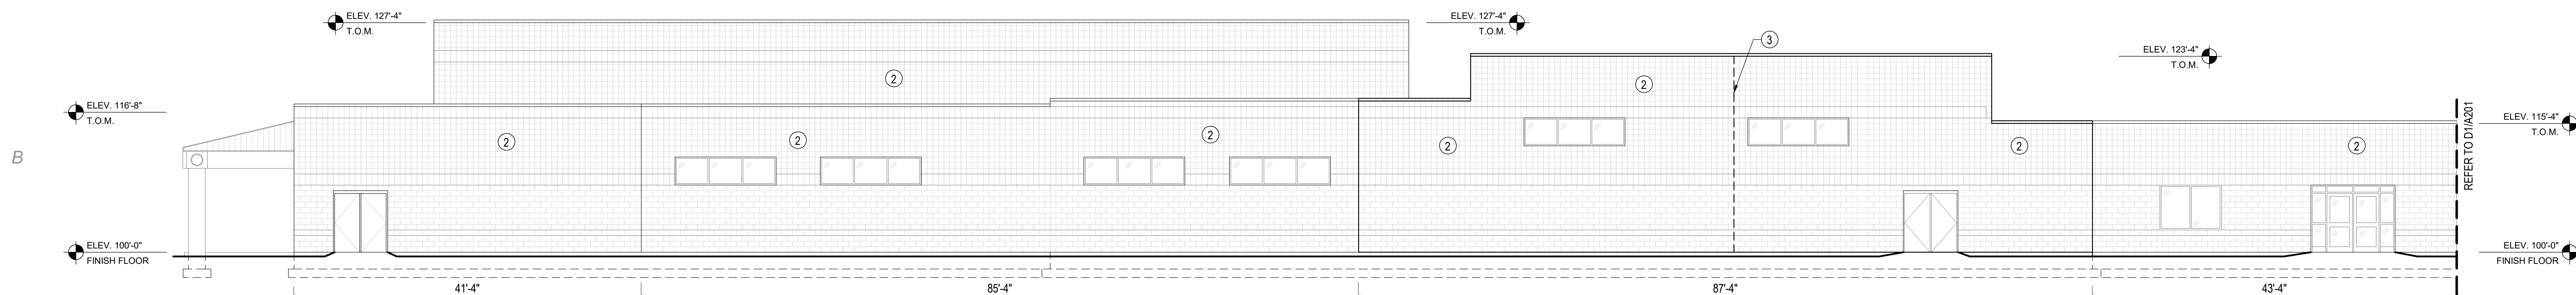
B1 NORTH ELEVATION
A201 | SCALE: 1/8" = 1'-0"

- 1. MASONRY HAS CRACKED AND MOVED OUT OF ALIGNMENT, REPAIR. SEE REFERENCE IMAGE 33/A204.
- 2. EXISTING MASONRY CLEAN & RE-SEAL.
- 3. CONTROL JOINT, REMOVE EXISTING CAULK & BACKER ROD. CLEAN JOINT & ADD NEW BACKER ROD & CAULK.
- 4. MECHANICAL ROOF TOP UNIT.
- 5. EXISTING EIFS MEDALLION, N.I.C.
- 6. EXISTING EIFS, N.I.C.
- 7. EXISTING EIFS CANOPY AND COLUMNS, N.I.C.

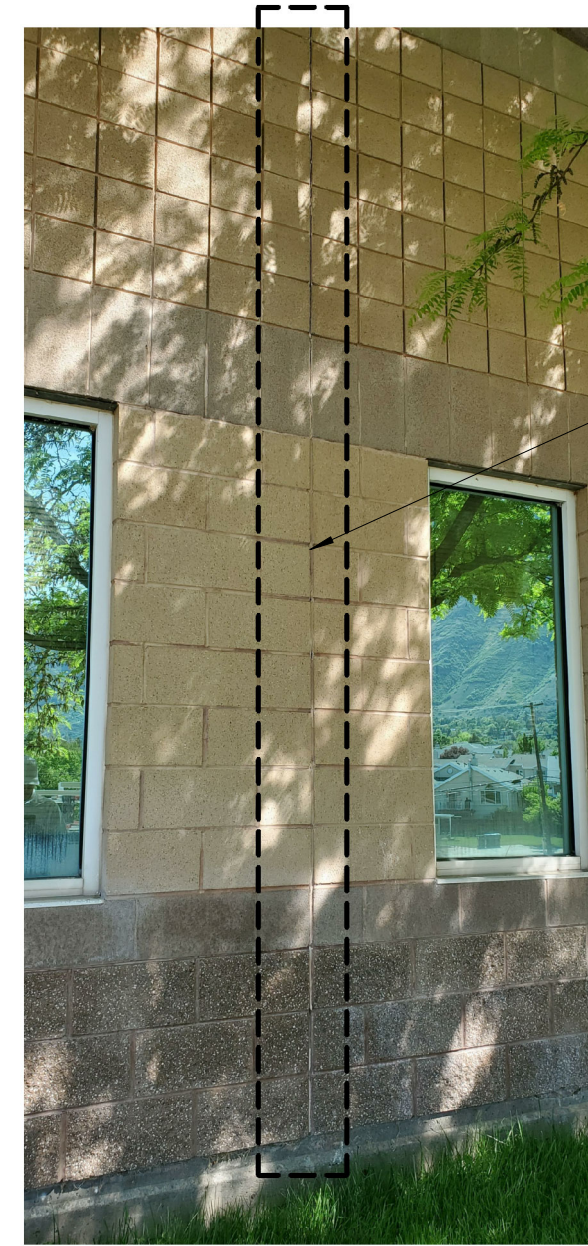
B2 PICTURE 32
A204 | SCALE: 1" = 1'-0"

CRACKED JOINT

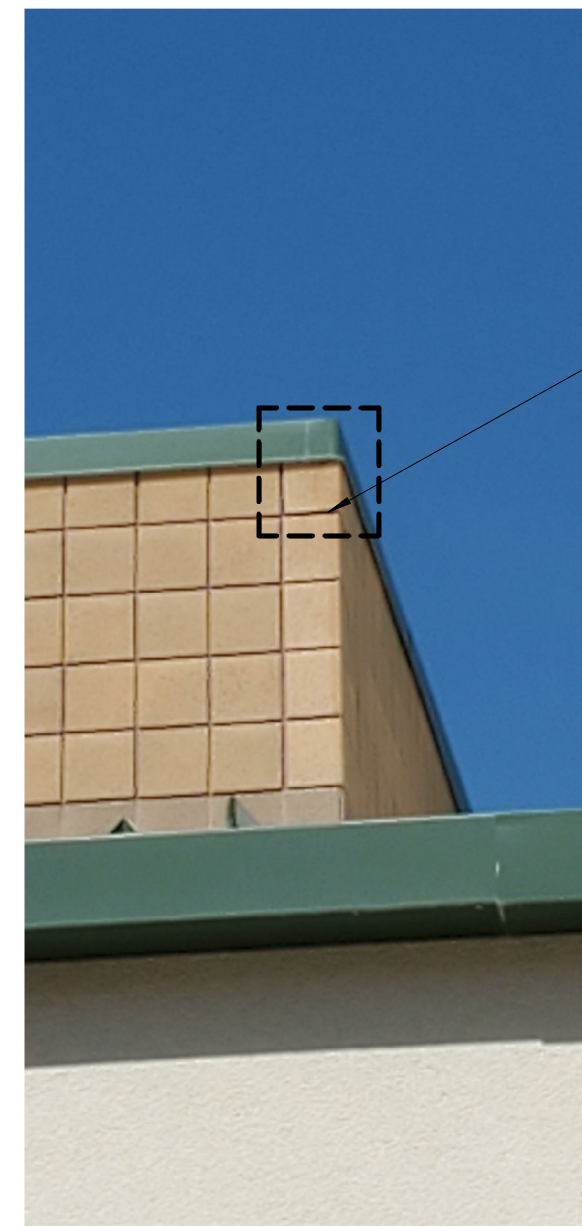
B3 PICTURE 33
A204 | SCALE: 1" = 1'-0"

MASONRY IS
BROKEN AWAY
& CRACKED
