# TIMPVIEW HIGH SCHOOL EVALUATION

3570 North 650 East Provo, Utah 84604

**BUILDING EVALUATION**

The following report is the architectural evaluation of Timpview High School for Provo School District. The evaluation took place in November 2012.

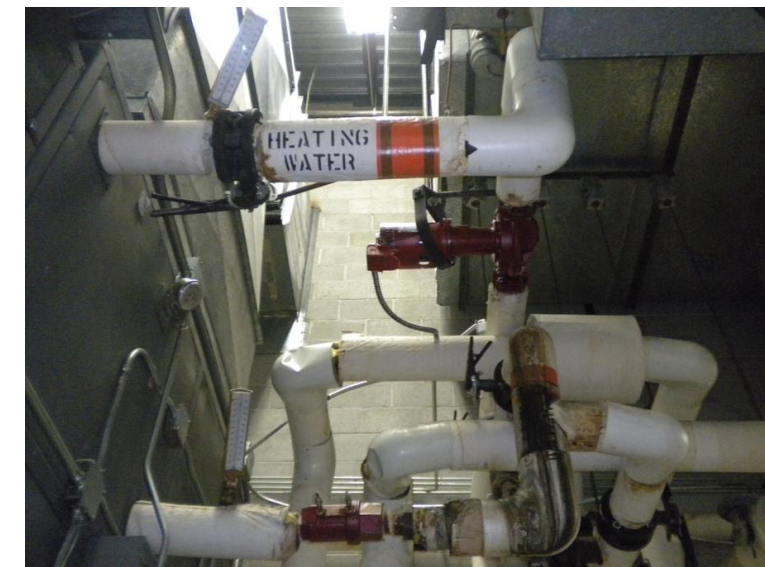
Figure 2. AHU Coil Piping & Coil Pump

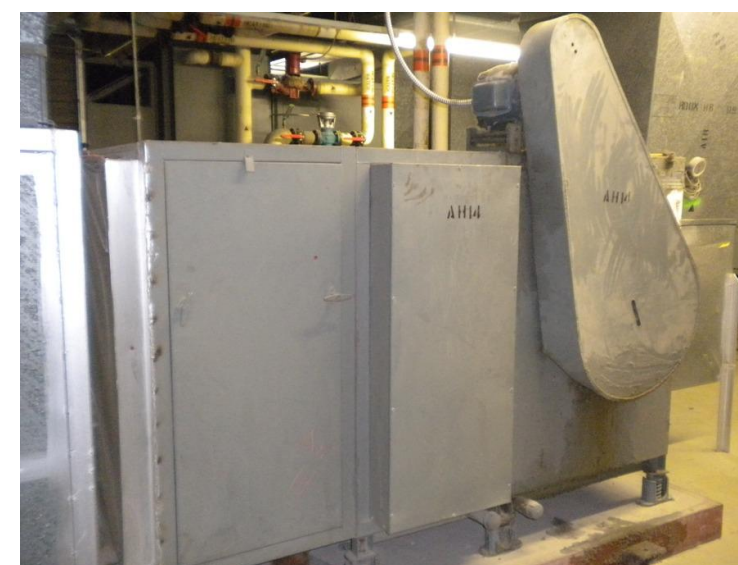
Figure 3. Existing HW/CW Control Station AHU

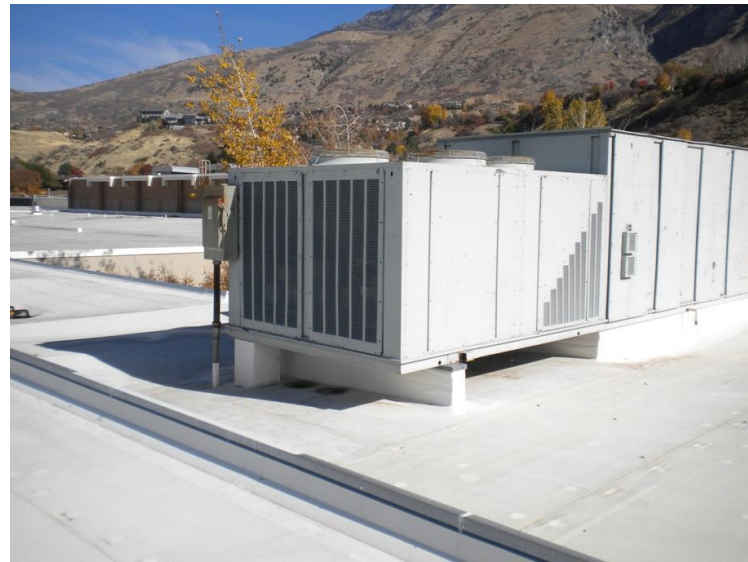
Figure 4. 1991 Classroom Addition Gas/DX RTU

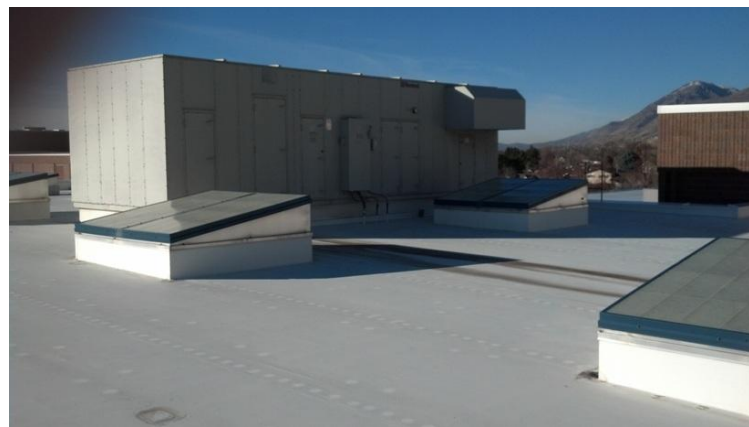
Figure 5. Gymnasium HW/CW Rooftop Unit

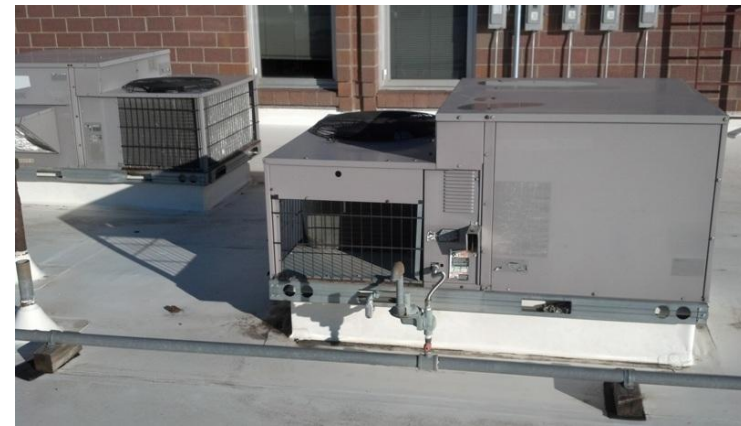
**Figure 6. Typical Gas/DX RTU**

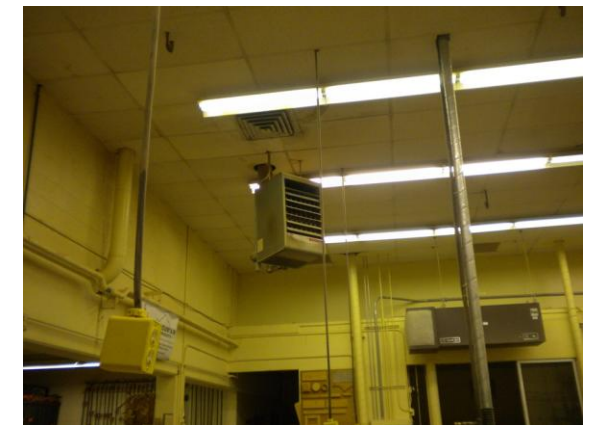
**Figure 7. Shop Gas Unit Heater**

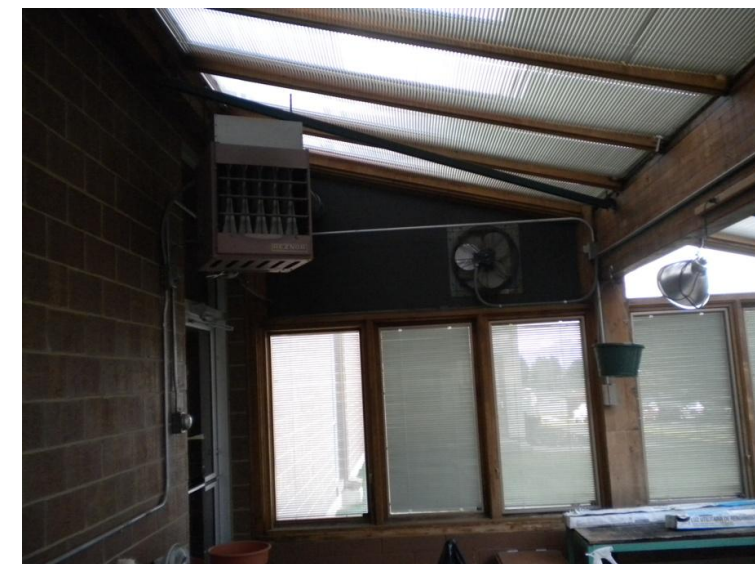
**Figure 9. Greenhouse U.H. & Vent Fan**

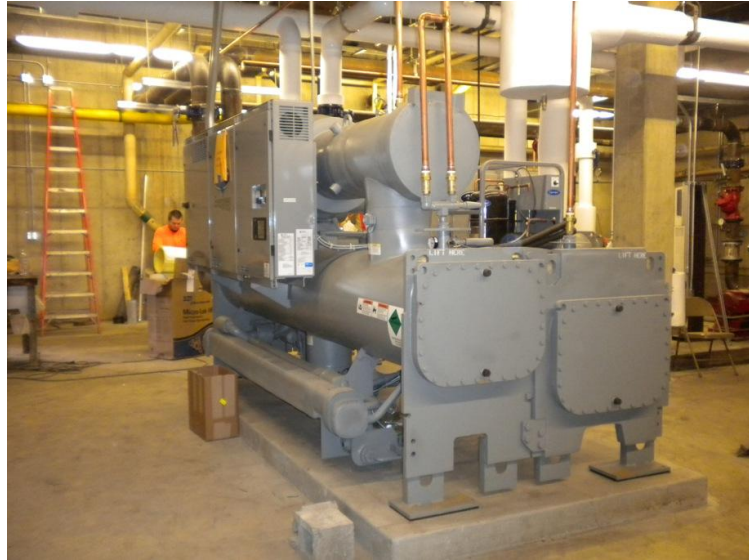
Figure 9. New Water Cooled Chiller (2012)

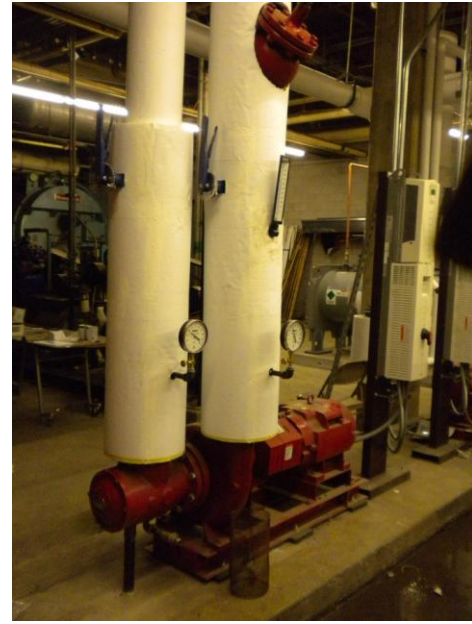
Figure 10. New Chilled Water Pumps (2012)

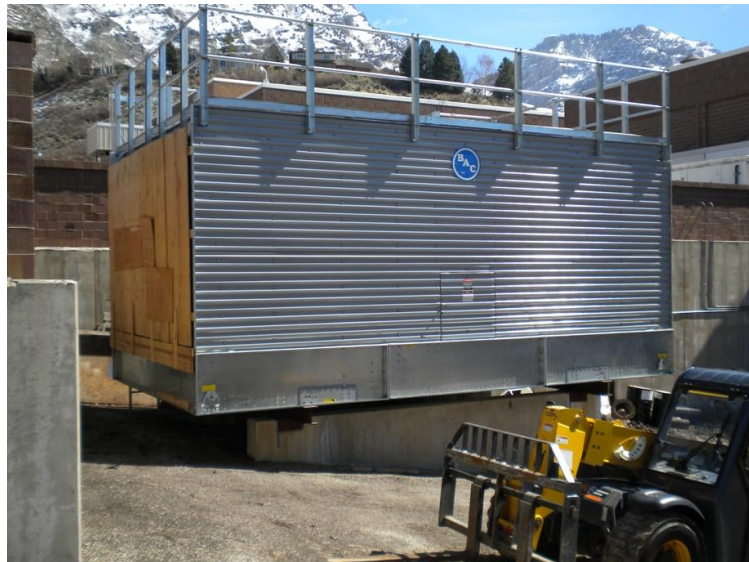
Figure 11. New Cooling Tower (2012)

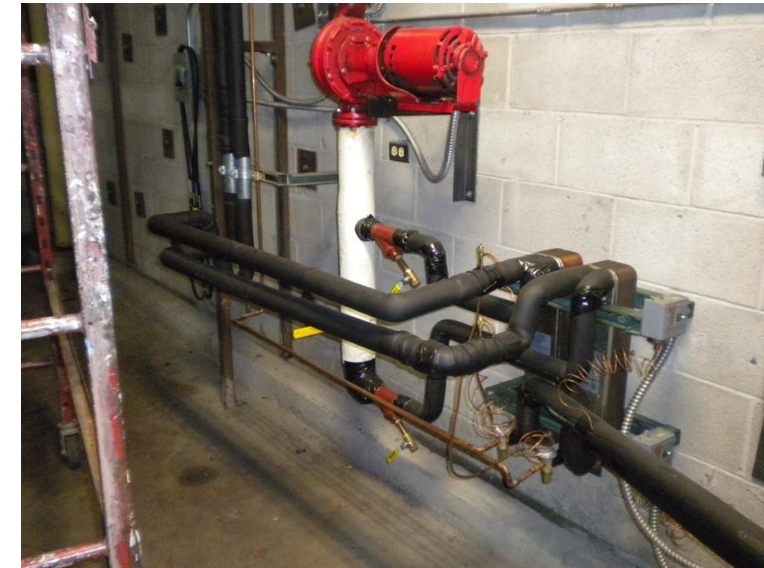
**Figure 13. Administration Area Heat Exchanger**

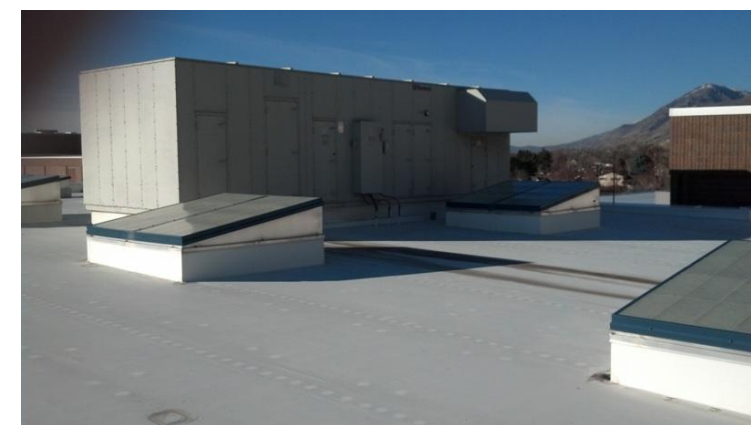
**Figure 14. 1991 Addition Gas/DX Rooftop Unit**

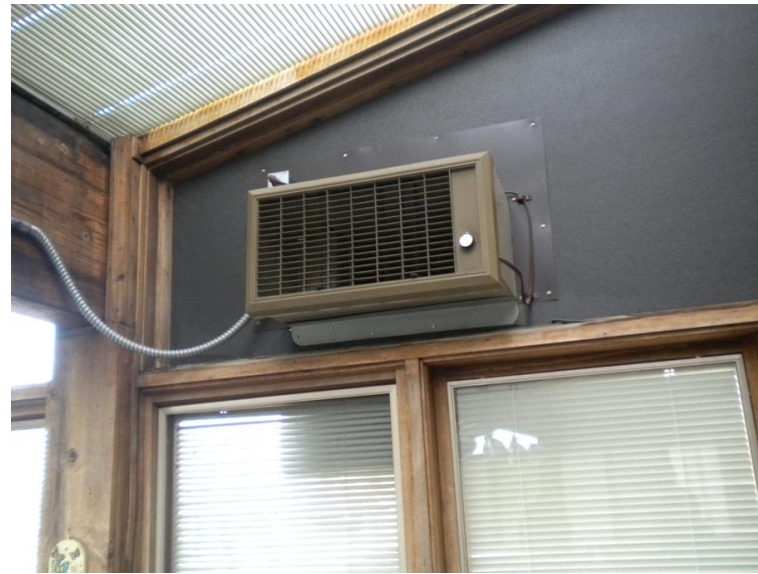
Figure 16. Greenhouse Evaporative Cooler

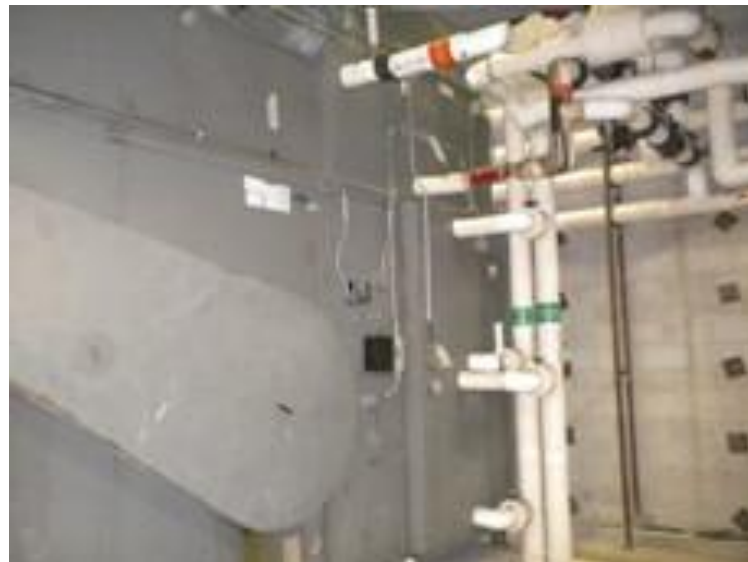
Figure 17. Existing Central Station Air Handler

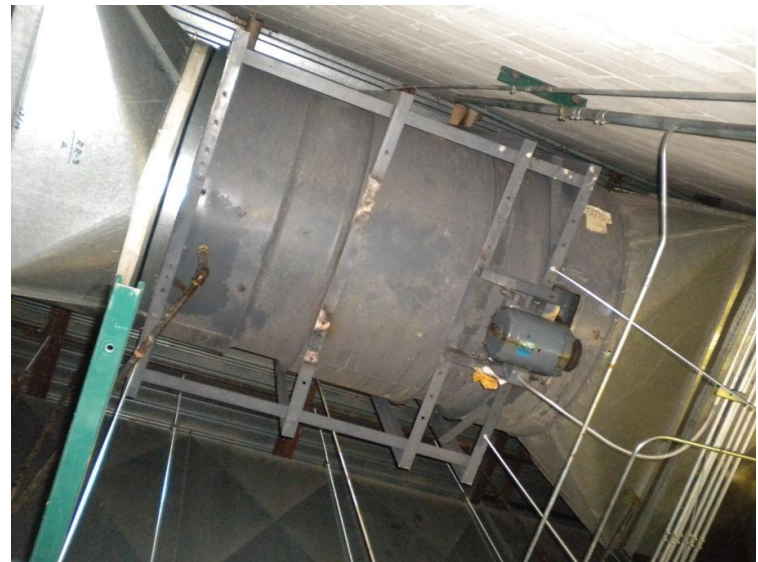
Figure 18. Return Fan Control in Mezzanine Fan Room

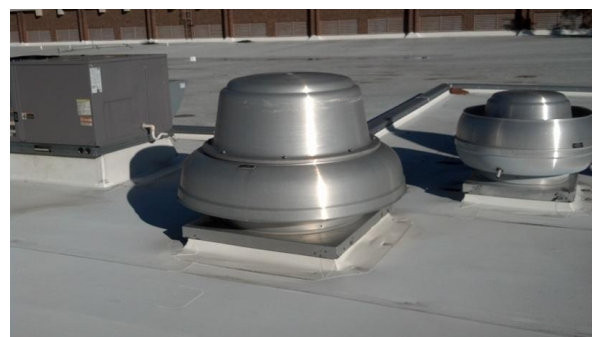
**FIGURE 19. Typical Toilet Room Roof Exhaust Fan**

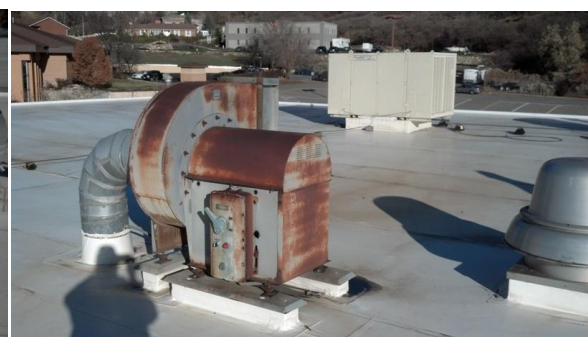
**FIGURE 20. Shop Area Utility Exhaust Fan**

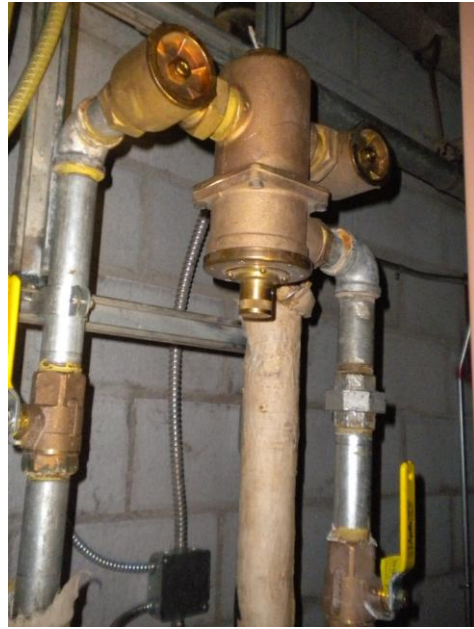
Figure 25. Galvanized Waters at Pipe Chase

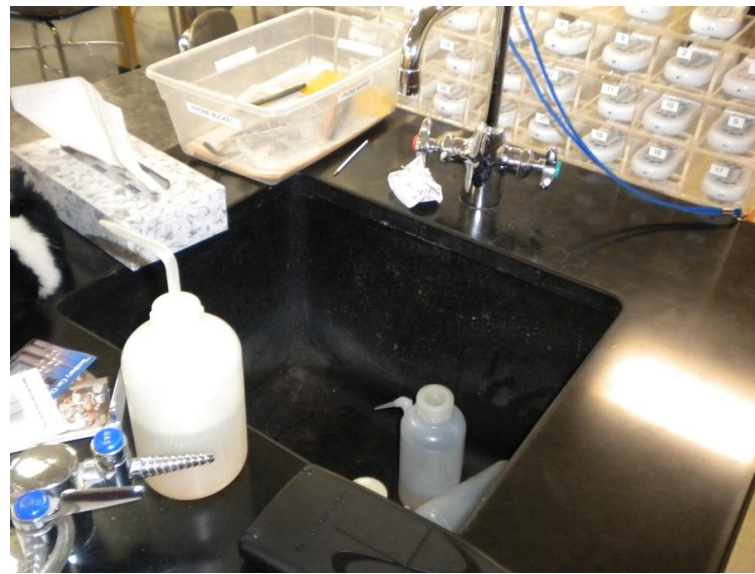
Figure 26. Typical Science Room Sink

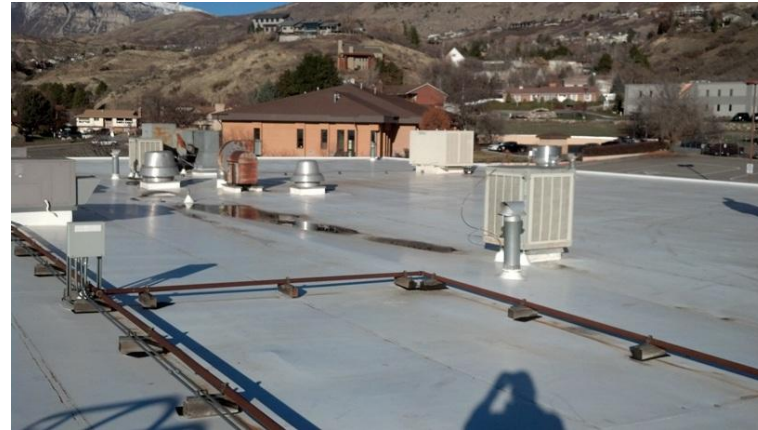
Figure 36. Typical Gas Piping Installation on Roof

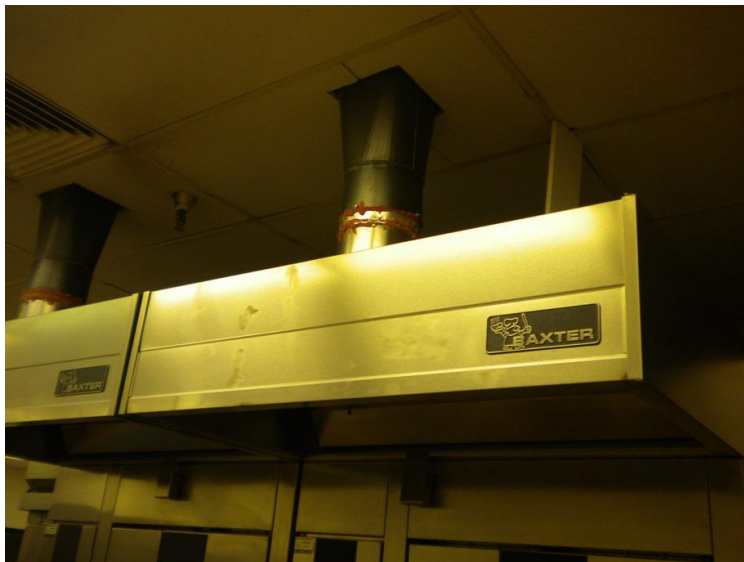
Figure 37. Kitchen Cook Hood

- The majority of the kitchen mechanical and plumbing systems are original to the school.
- Cooking and dishwasher hoods and roof exhaust fans are original to the building. Systems are past their useful life and should be considered for replacement.
- It appears the current use of the equipment at the main cook hoods has been modified over the years. Hood design should be modified to meet current code and program requirements.
- Individual Duo-Aire units provide make-up air and exhaust for each of the (3) cook hoods and the dishwasher hood. Units are beyond their useful life and should be considered for replacement.
- The main class I hood is provided with a wet chemical suppression system, but no automatic gas valve was observed.
- Automatic gas valve at the class II hood was not observed in the kitchen area.

- Kitchen HVAC & Exhaust systems are well beyond their useful life. Systems should be considered for replacement to more energy efficient systems, as well as updated to current use requirements of kitchen.
- Kitchen plumbing systems should be considered for replacement due to piping leaks, etc.

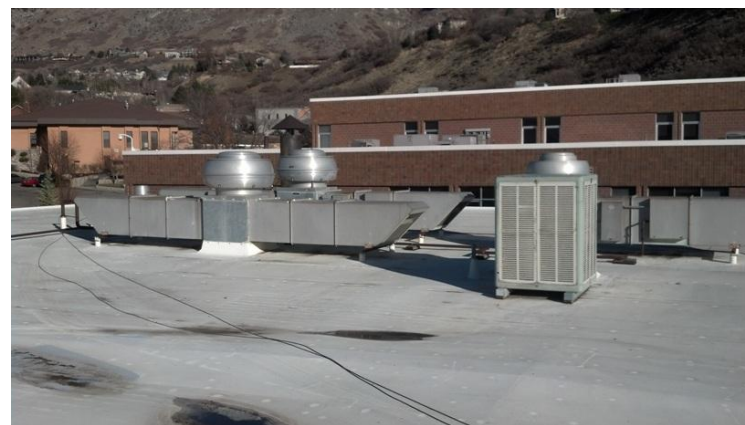
Figure 38. Kitchen Hood Make-Up Air/Exhaust System

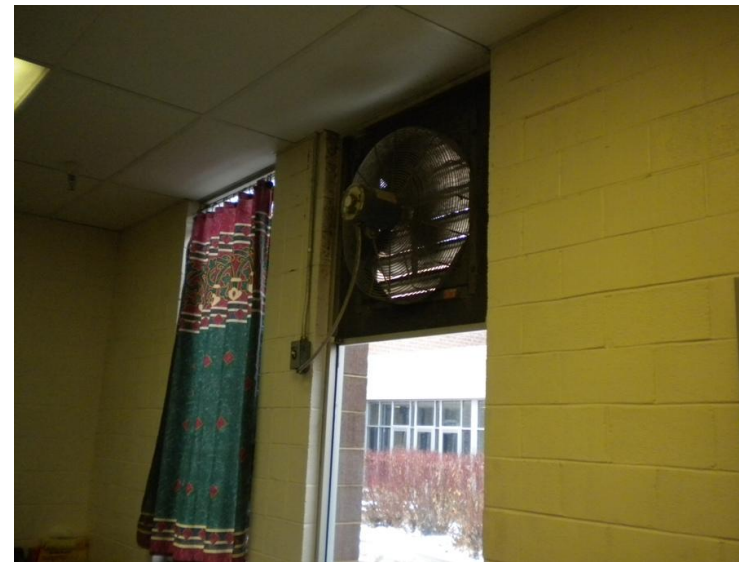
- A wall type prop fan provides ventilation at the dishwasher area.
- Domestic cold and hot water lines are galvanized.
- Water filters have been installed on cold waters at the kitchen equipment and sinks.
- No vacuum breakers at sink faucets and hose bibbs in the kitchen area. This is a violation of current code requirements.
- Kitchen is equipped with garbage disposers.
- No grease interceptor is provided at the kitchen area.
- Waste piping from the kitchen has just been repaired due to rusted pipe. Piping was observed to have a considerable amount of grease build-up.

Figure 39. Prop Fan at Kitchen Dishwasher Area

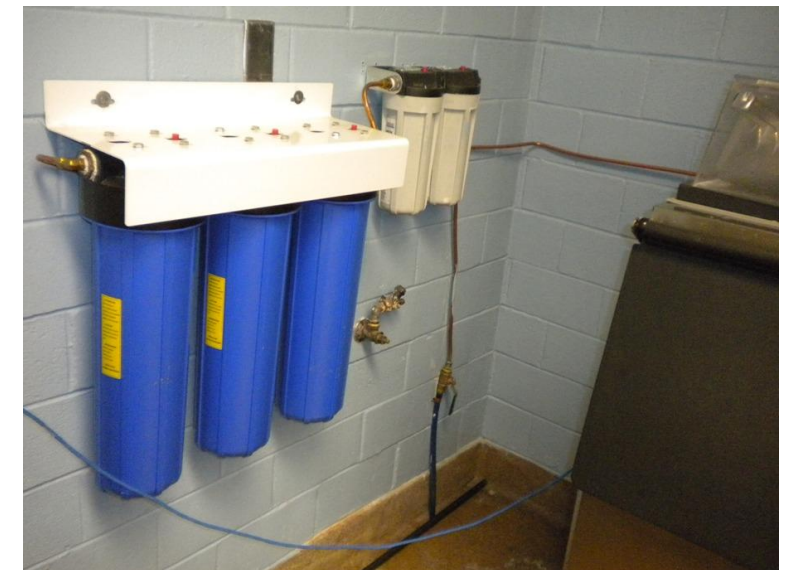
Figure 40. Kitchen Water Filters
