# TIMPVIEW HIGH SCHOOL EVALUATION

3570 North 650 East Provo, Utah 84604

**BUILDING EVALUATION**

The following report is the architectural evaluation of Timpview High School for Provo School District. The evaluation took place in November 2012.

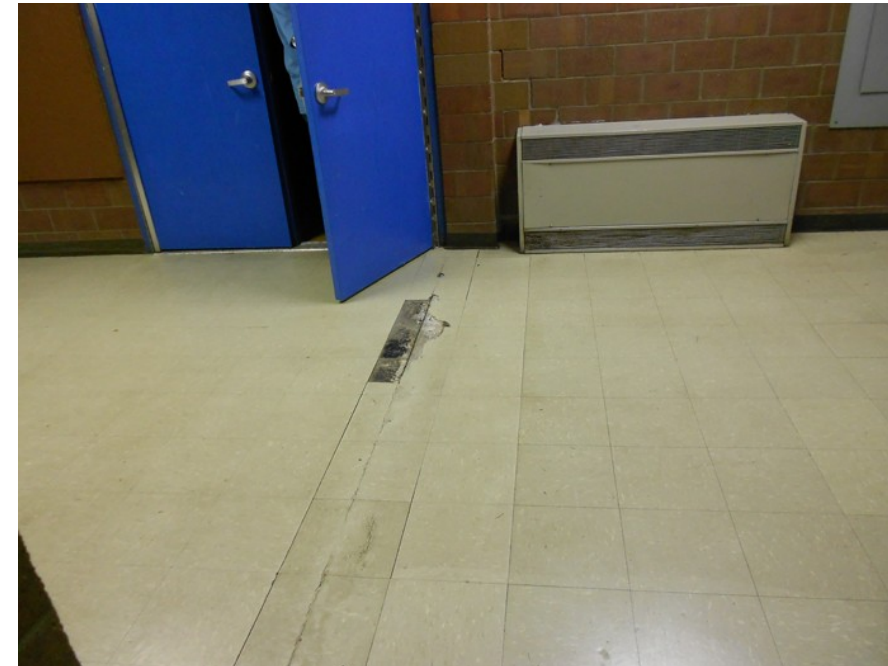
Figure 1.

- The carpeting though out the building is in fair condition. It shows signs of wear and stains. Optional replacement.
- The epoxy poured, painted with Fleck floors, like those found in the Commons area, are in okay condition and not coming up, but aesthetically look terrible.

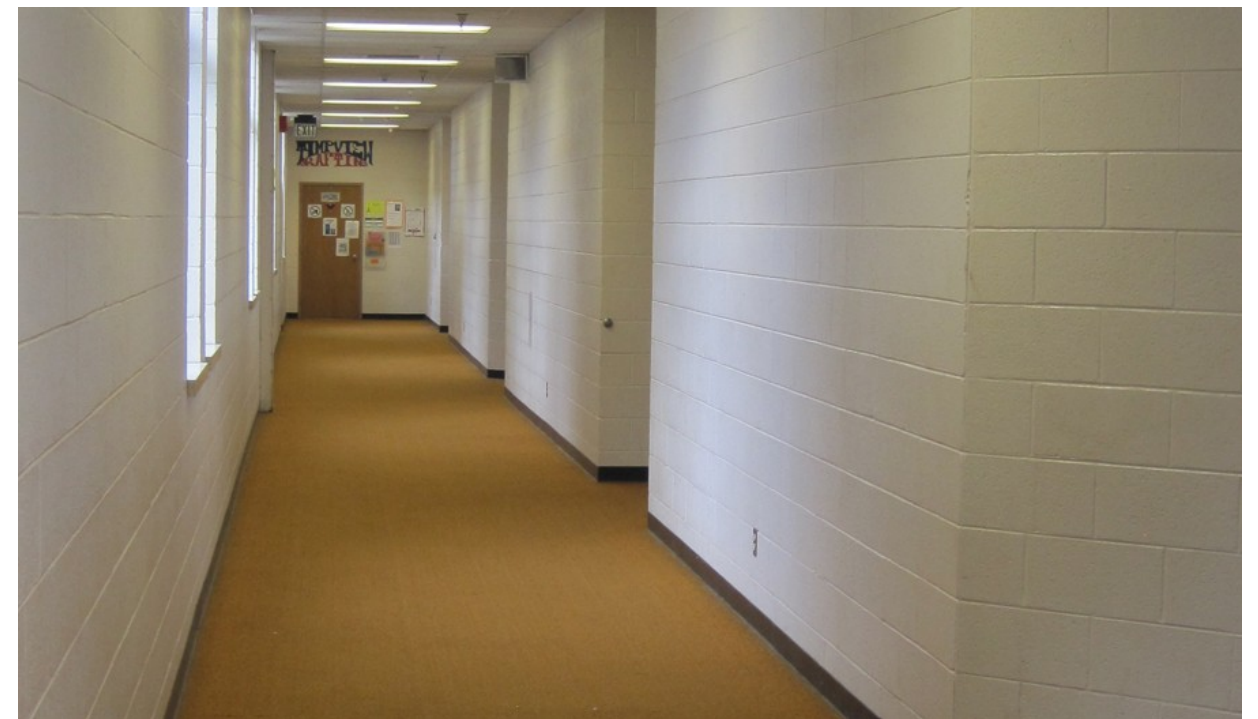
Figure 2.

- The finishes have ages and have has some updating to them such as new paint, new carpet and flooring, in certain areas of need.
- Across the school, except for the newer additions, the finishes are in need of updating or replacement.

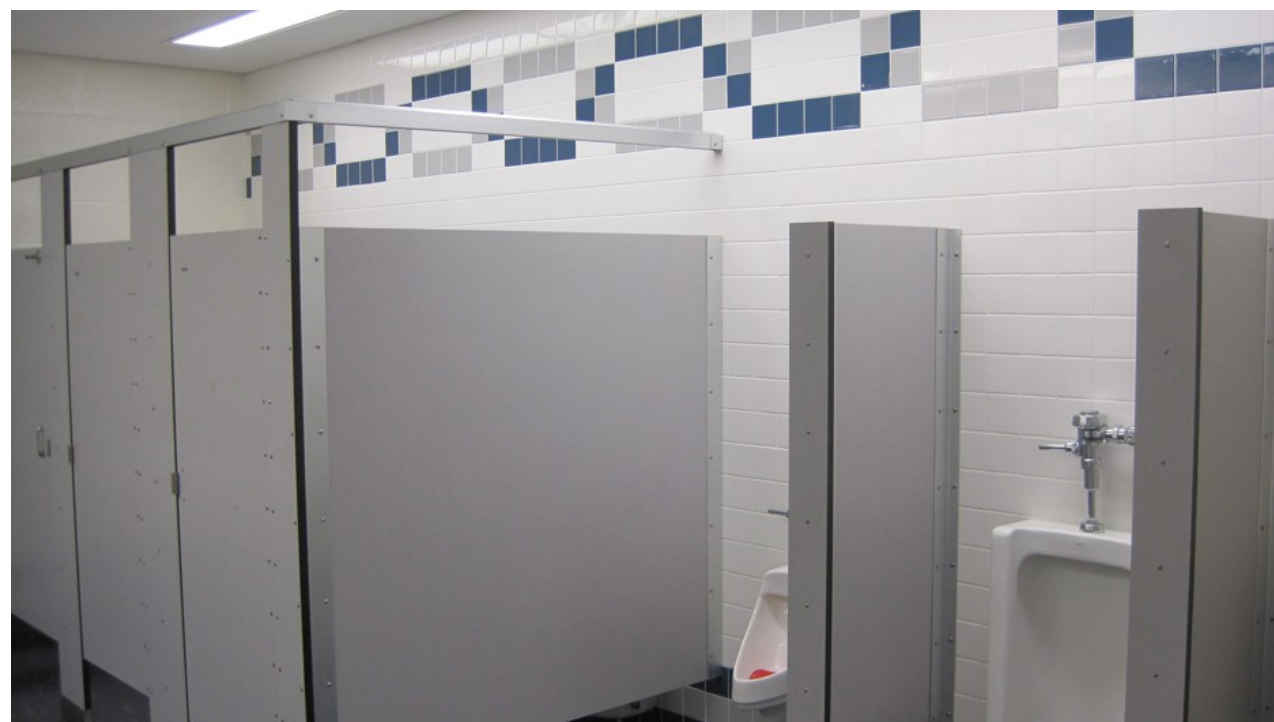
Figure 1.

- The existing restrooms need to have grab bars installed and brought up to ADA requirements. The mirrors, soap and towel dispensers seem to be in good condition.

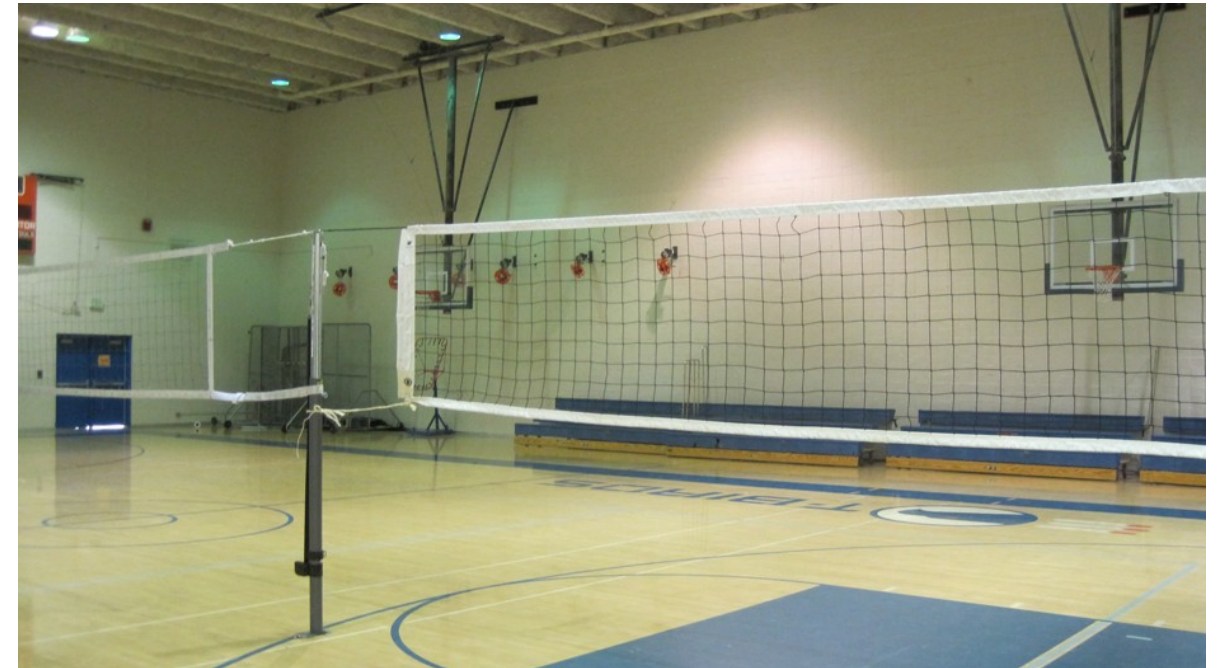
Figure 1.

- The gymnasium equipment is in good condition, with the exception of the south practice gym and wrestling room under the dance room, which is in poor shape

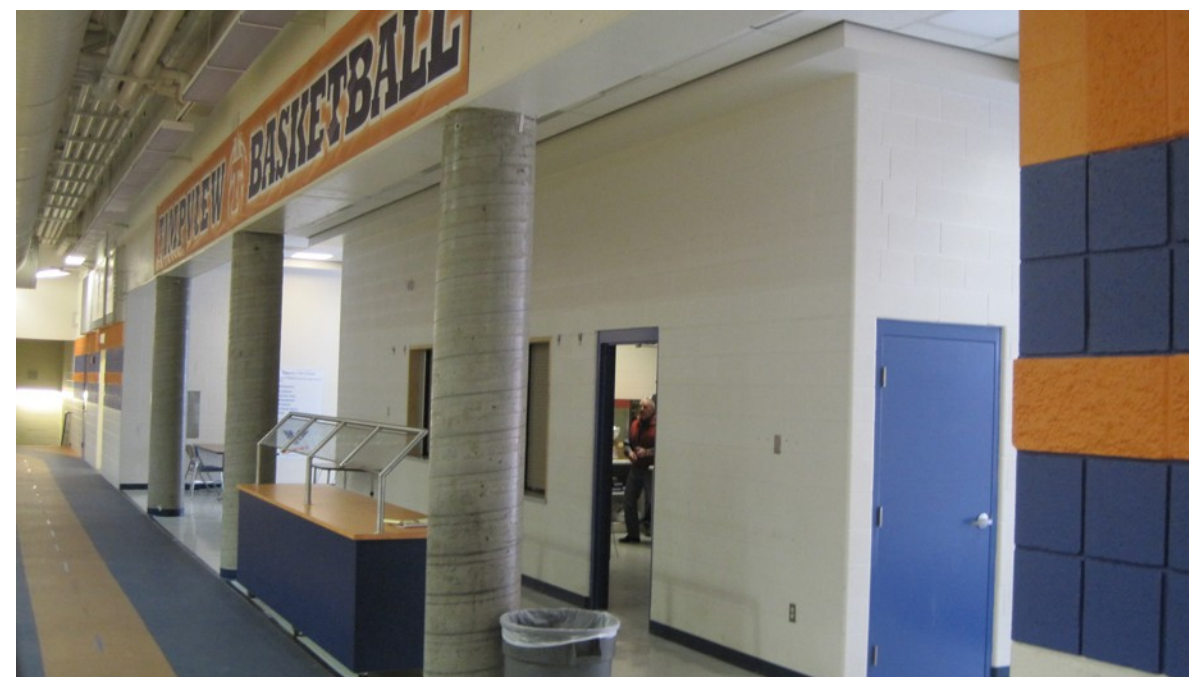
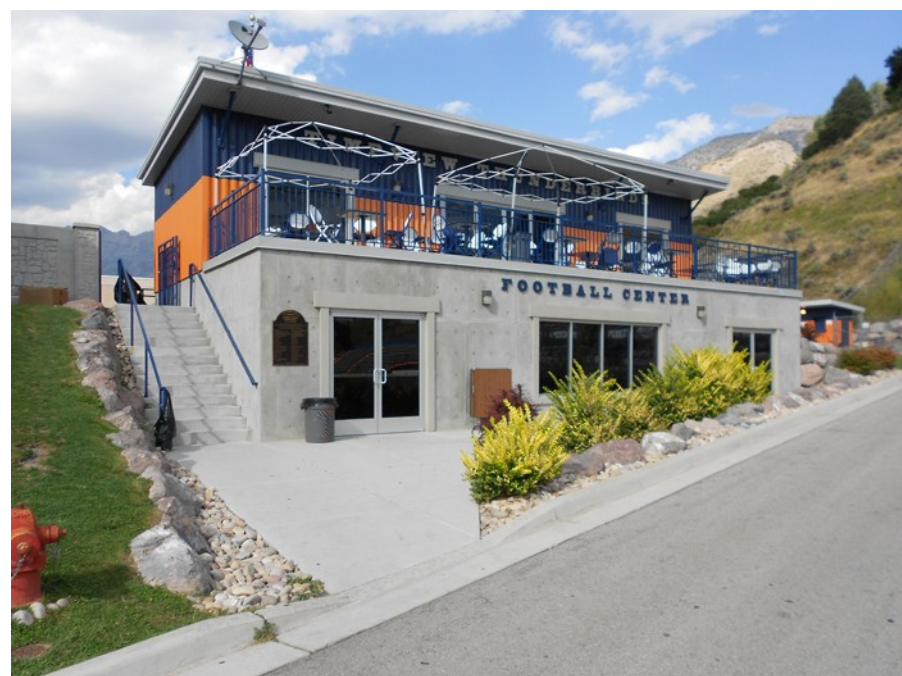
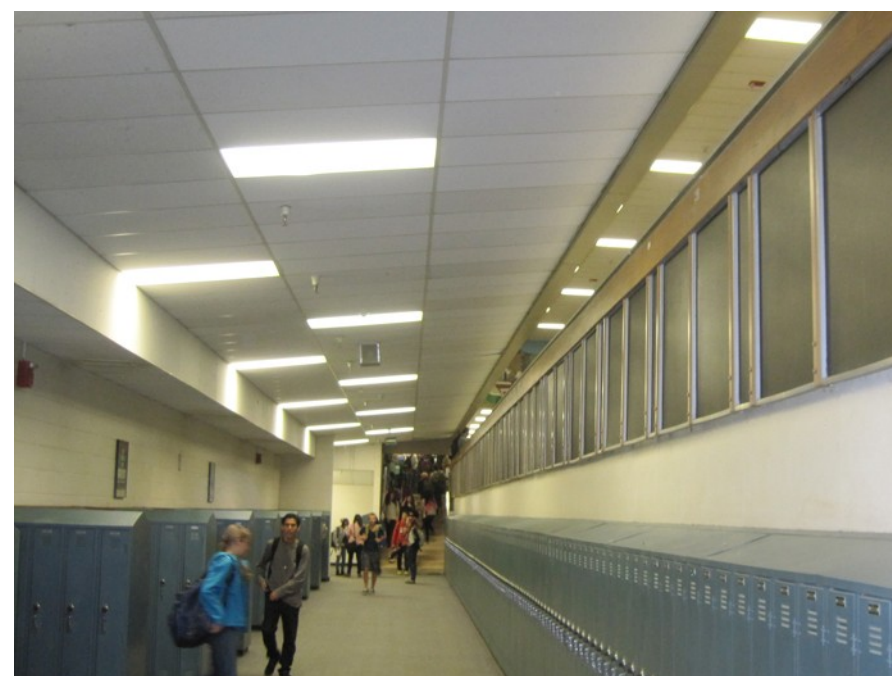
- A - ADA accessibility to entrances and other parts of the building insufficient because of elevation changes on site.
- B - The use of lifts and small elevators are not sufficient.
- C - Some corridors are very small and create narrow paths that could be problematic.
- D - Egress is a problem for ADA routes.
- E - Poor location, lacks visual control.
- F - Some leaking through concrete wall in basement under stage.
- G - Steep student parking lot.
- H -
- I - Brick veneer cracking and damage at some exterior corners and in location at foods dept.

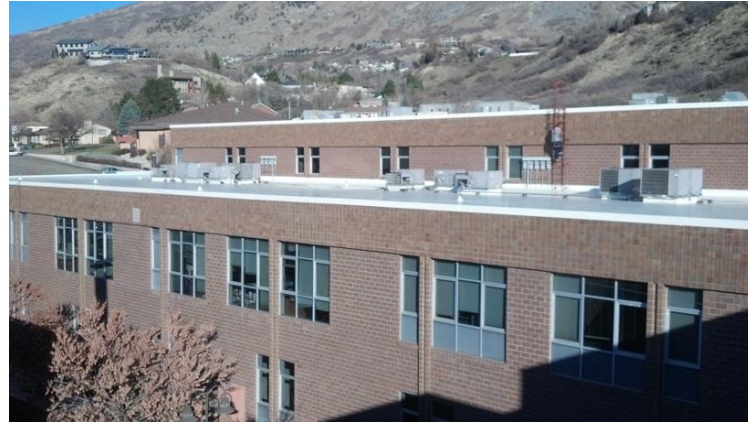
Figure 15. Industrial Arts Area Packaged Rooftops

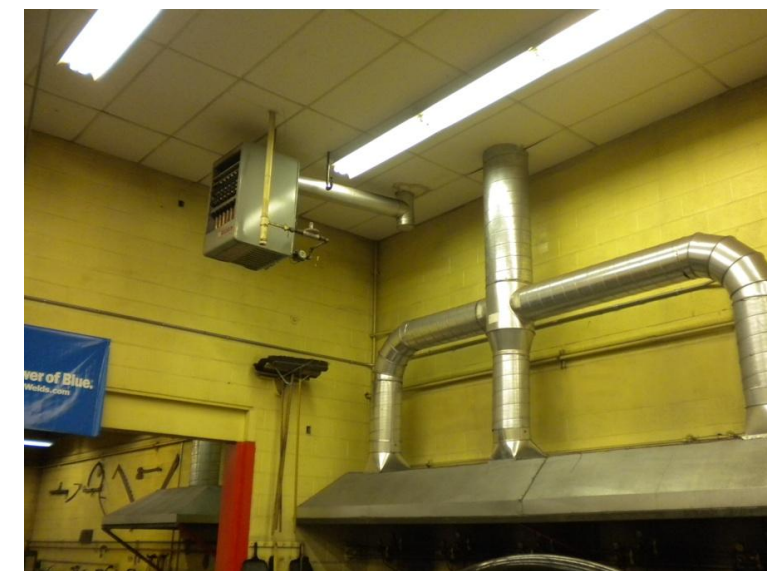
**Figure 22. Shop Hood**

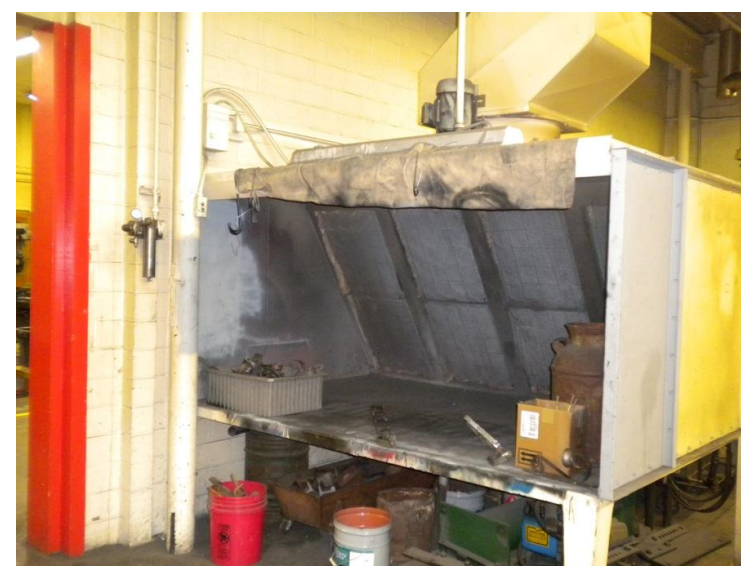
**Figure 23. Shop Paint Booth**

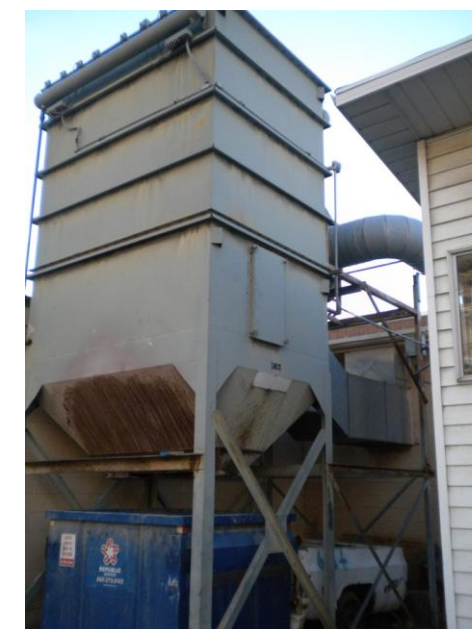
**Figure 24. Sawdust Collector**

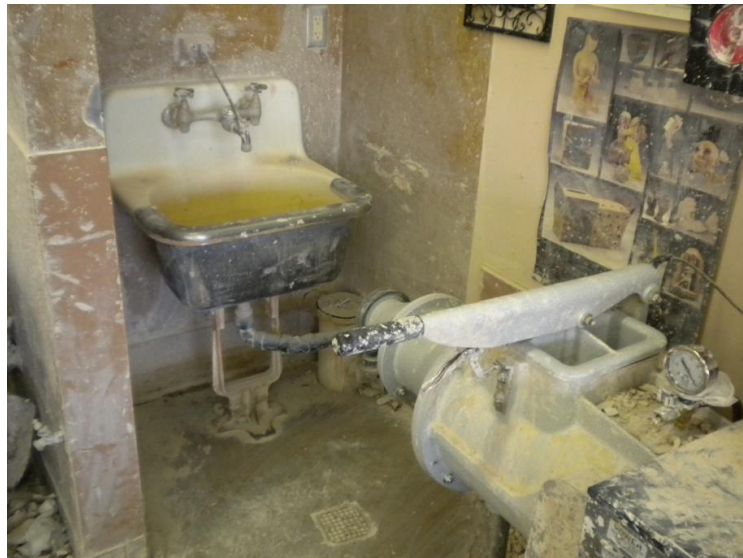
Figure 27. Pottery Area Sink and Clay Trap

- Pottery area sinks are in need of replacement. Would recommend upgrading the clay trap at the main pottery sink.
  - Dark room sinks are stainless steel and poly type sinks. Sinks should be considered for replacement as required for program.

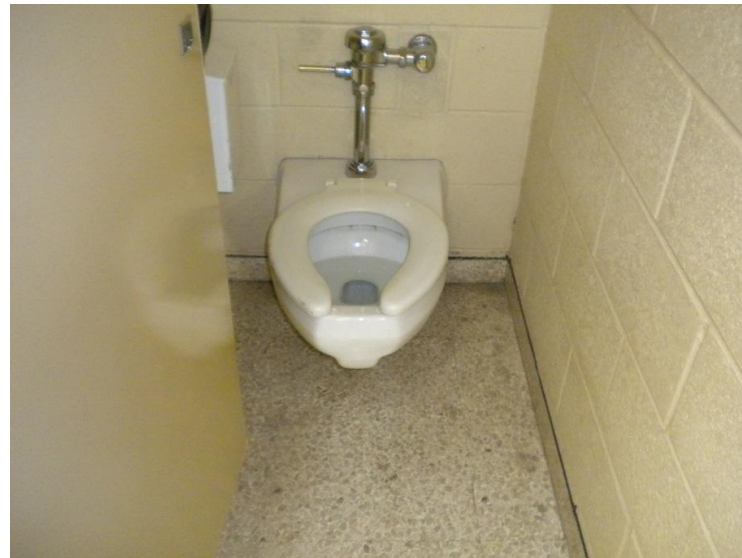
Figure 28. Typical Wall Mounted Water Closet

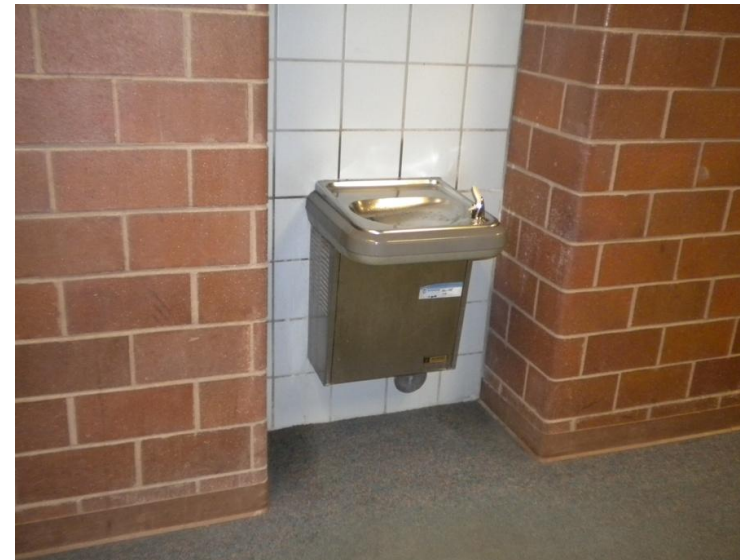
Figure 31. Refrigerated Drinking Fountain

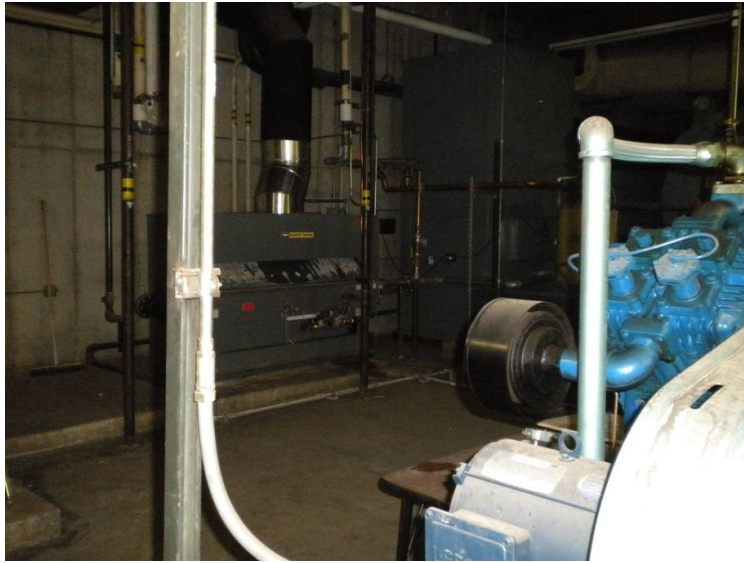
Figure 35. Laars Domestic Water Heater

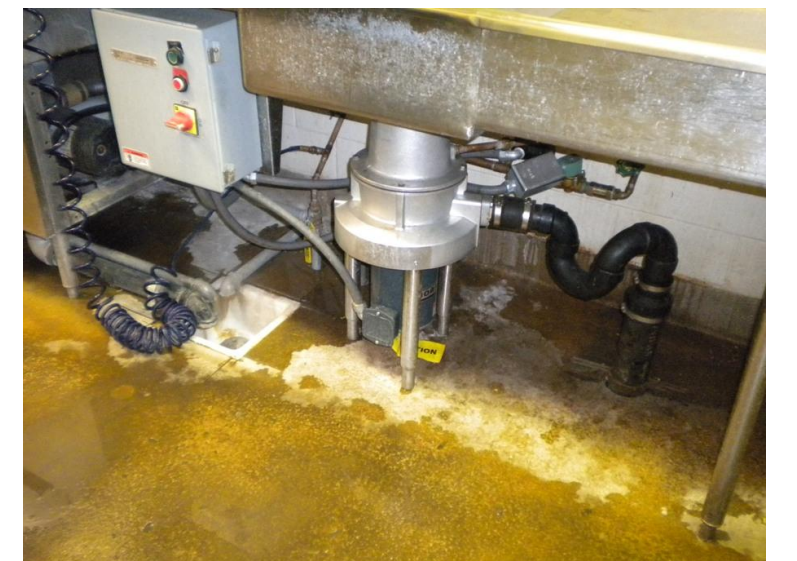
Figure 42. Kitchen Disposer
